A Major Landslide on Greers Ferry Lake

Arkansas Geological Commission

May 19, 2005

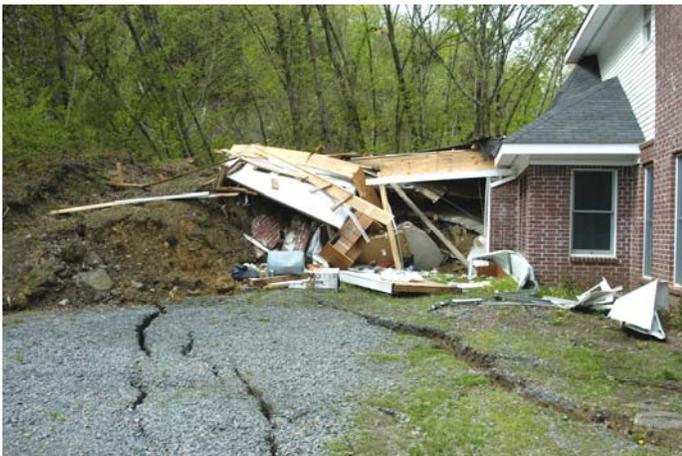
Early on the morning of March 28, 2005, after two days of rain, a significant landslide occurred on the north side of Stevens Point on the south shore of Greers Ferry Lake. The slide collided, in part, with a house owned by Shirley Bradford, crushing the garage (Figure 1) on the south side of the house and tearing a small room off the west side (Figure 2). The slide ultimately involved an area extending from a sandstone ledge over one hundred feet in elevation above the house down to and into the lake over one hundred feet in elevation below the house and extending to either side of the house.

Figure 1. Bradford garage.

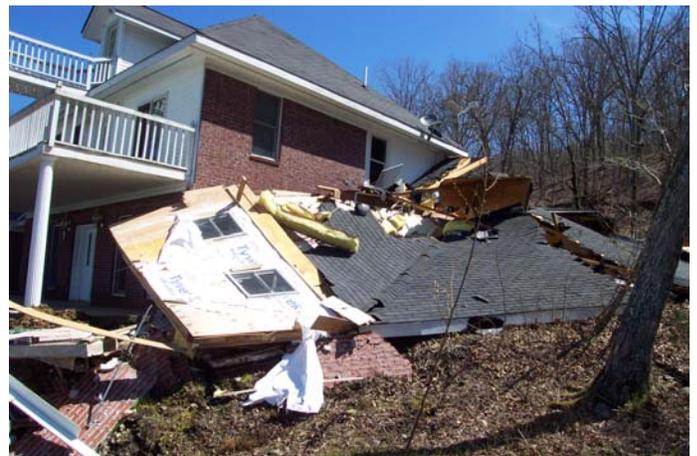
Figure 2. West side of Bradford house.

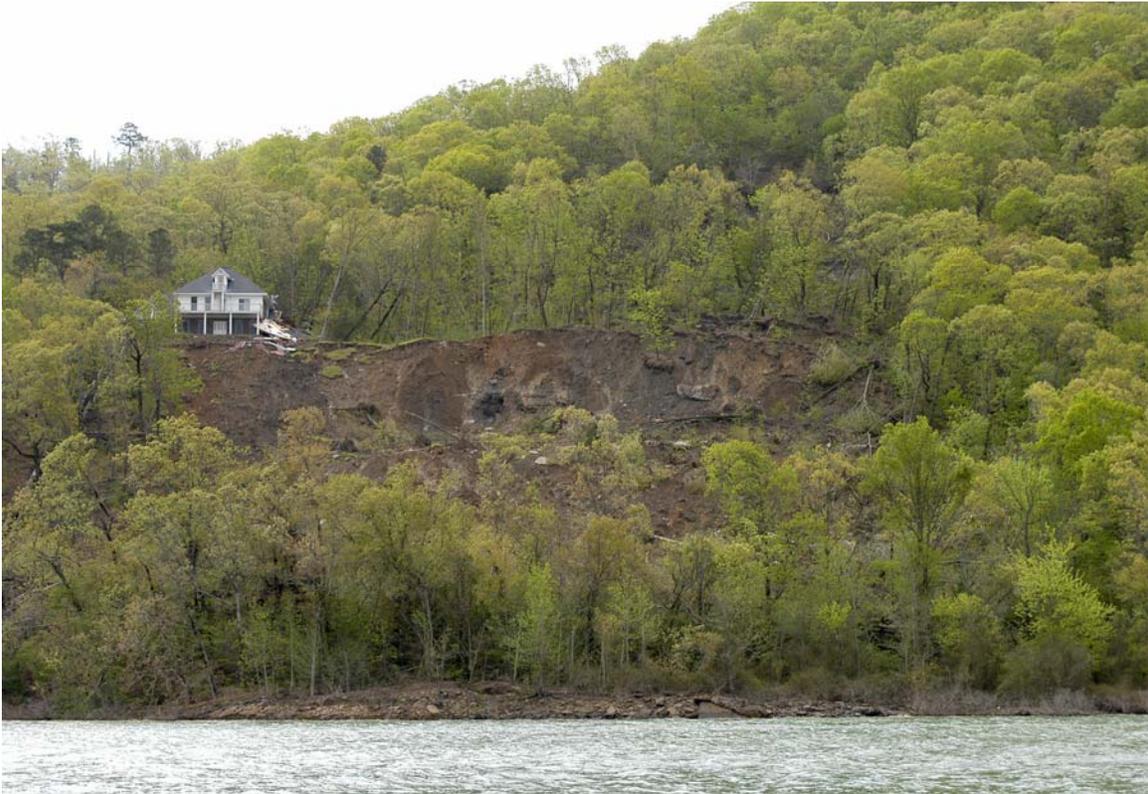
Figure 3. Slide area from Greers Ferry Lake. The upper portion of the slide is partially hidden by foliage still standing on the 600-foot contour ledge. (Photo courtesy of U.S. Army Corps of Engineers)

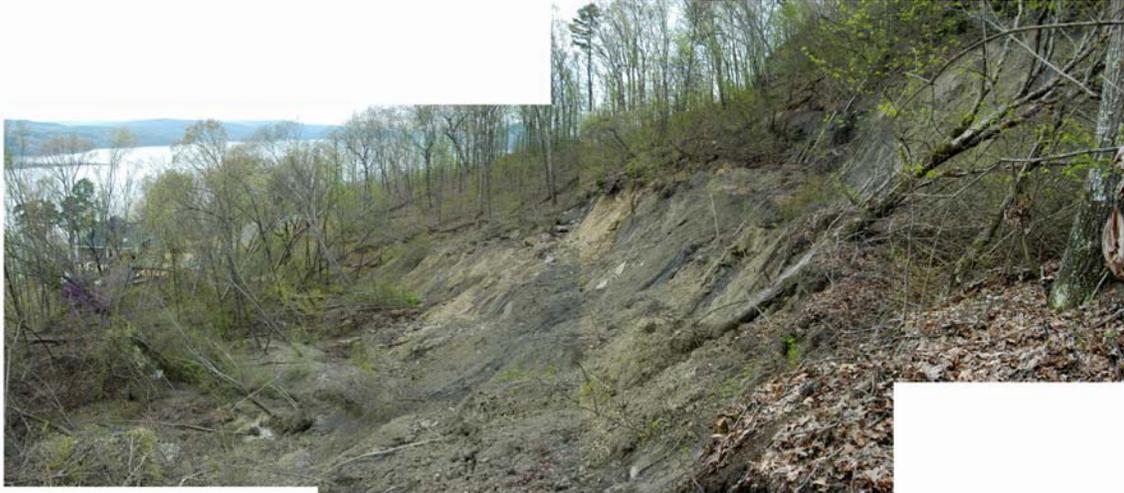
Figure 4. A view looking east north east at the upper portion of the slide area.

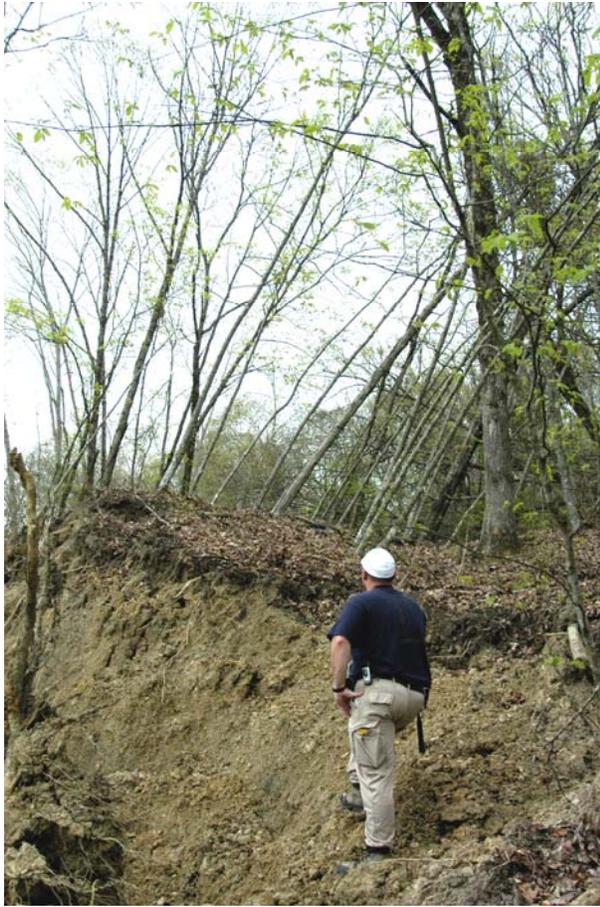
Figure 5. Rotational Slumping.

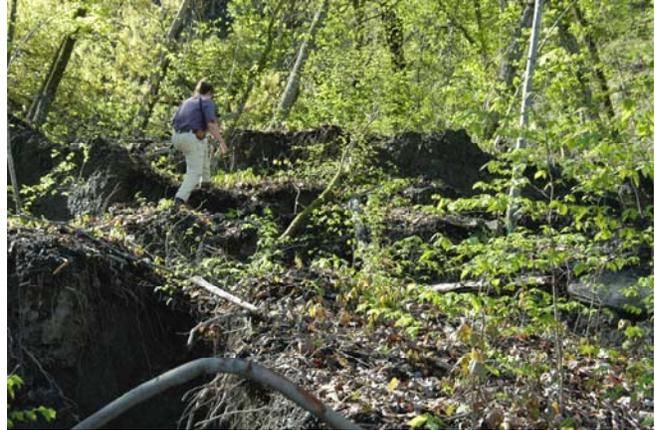
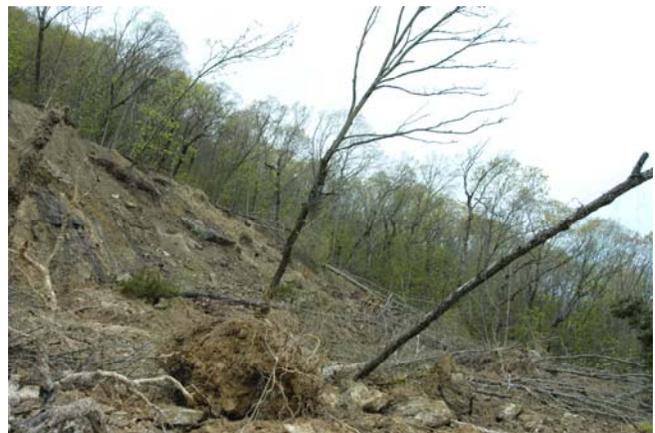
Figure 6 (above). Translational slumping.
Figure 7 (below). Lower portion of slide area.

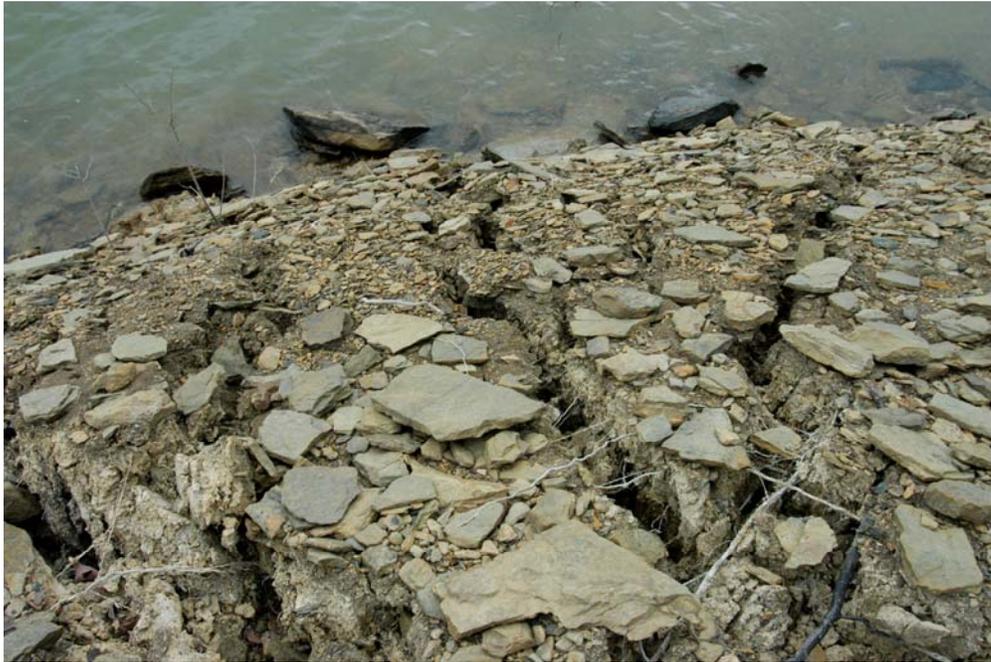
Figure 8. A pressure ridge extending into Greers Ferry Lake.

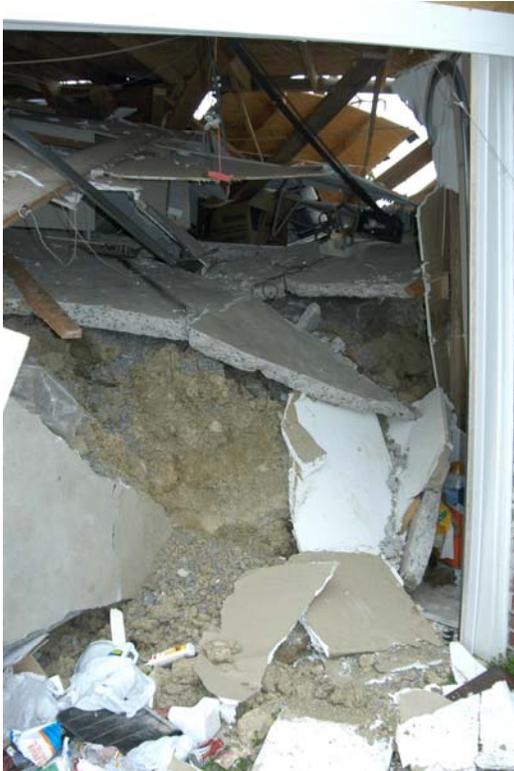
Figure 9 (left). A pressure ridge developed beneath the garage floor of the Bradford house.

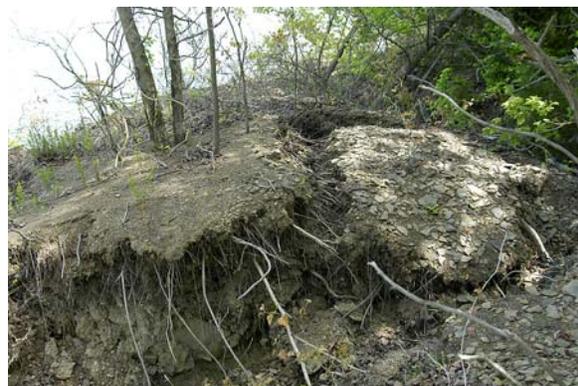
Figure 10 (above). Pressure ridge formed at lakeside.

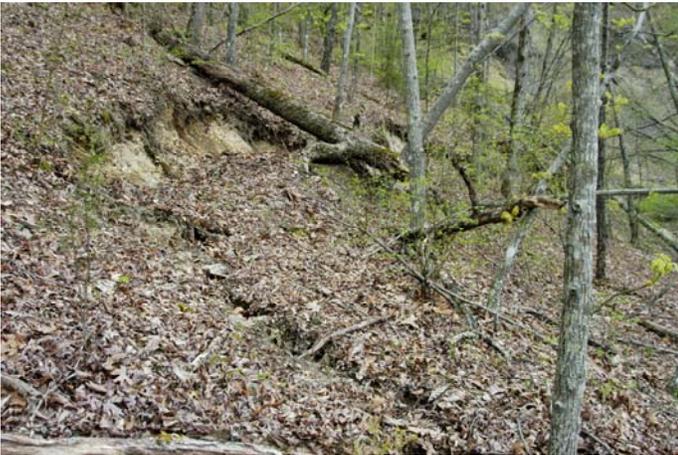
Displacements and cracked ground were noted adjacent to the main area of failure (Figures 11-13). These slide margin displacements tended to be shallow slips of just a few feet. Often their expression is presented via a low crown scarp dying out with distance from the main slide area. The toes of these marginal displacements are somewhat indeterminate due to the natural roughness of the slope and a thick forest-litter cover. These marginal slides extended up to a few tens of feet, reaching over a hundred feet in at least two cases, from the main slide track.

Figure 11. Slippage marginal to main slide.

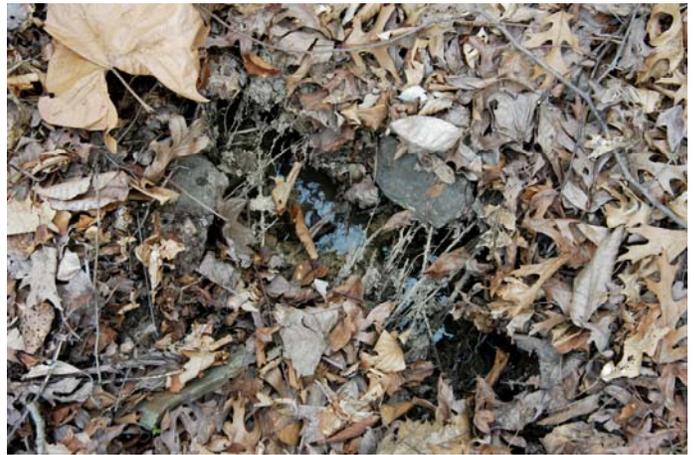
Figure 12. Incipient ground cracking due to minor slippage marginal to main slide. Note water in crack.

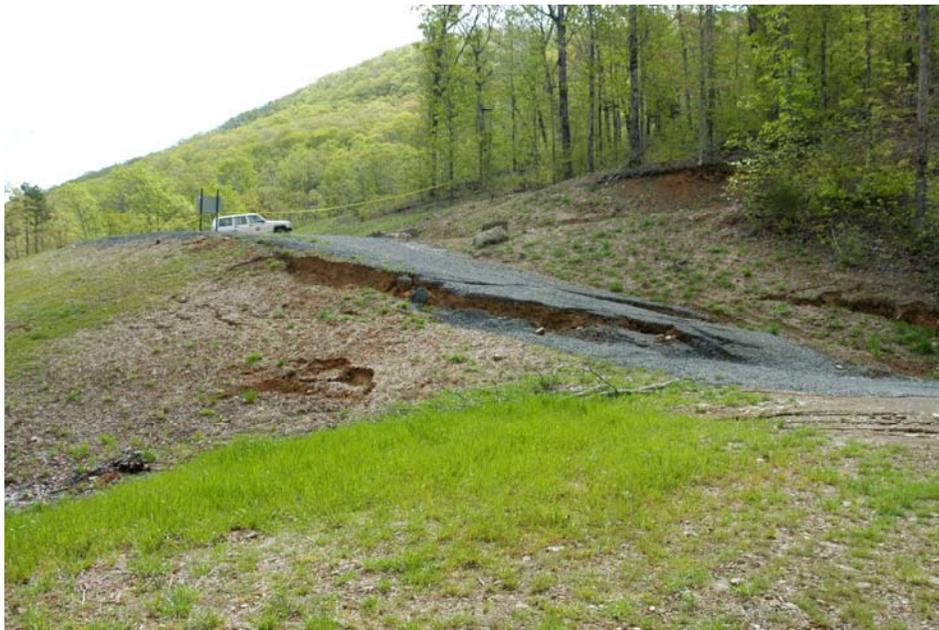
Figure 13. Ground displacement and subsidence east of the Bradford house.

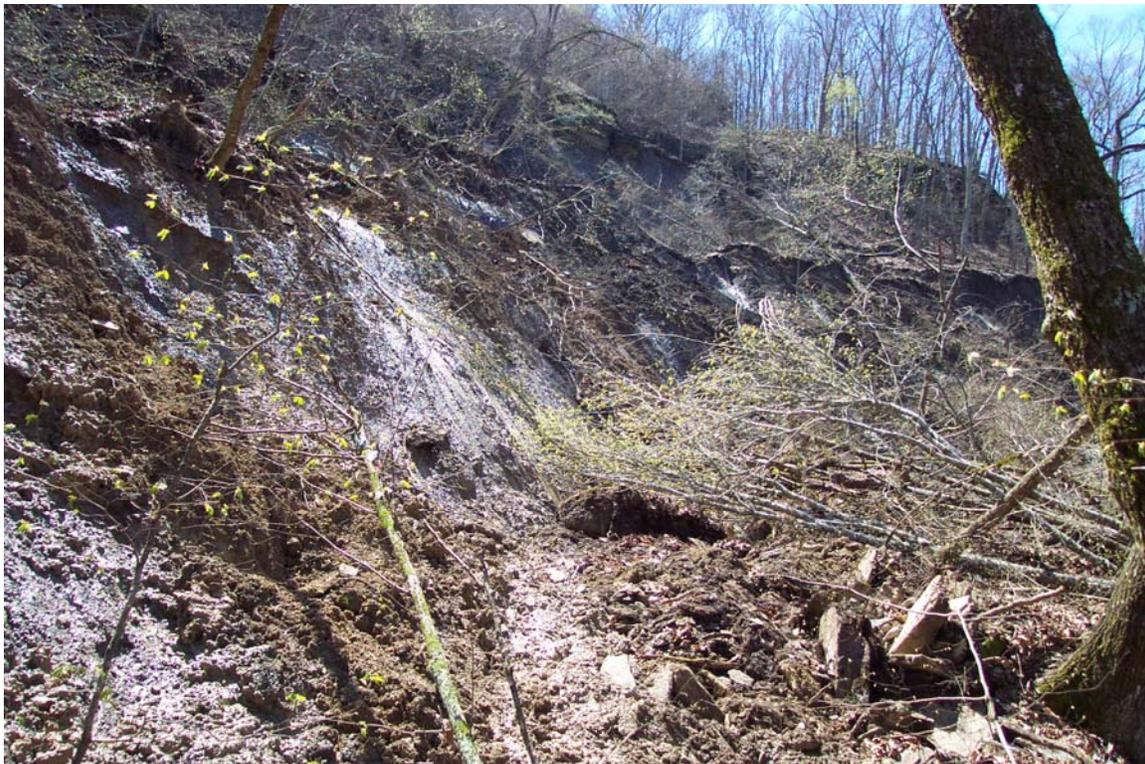
The March 28 events were preceded by two days of rain. On the day of the slide water was still running off the slope in several streams. Two of these streams formed small waterfalls over the main crown scarp (see figure 14). This water was mostly absorbed by the upper slide mass and did not result in overland flow much below the upper slide area. However, water was copiously seeping from the lower developing scarp formed by the 600-foot ledge. A week later the 600-foot contour ledge had more fully developed into a secondary crown scarp which displayed persistent flow from a joint in the sandstones several feet below the overlying surface. Observations around the slide area suggested that upslope runoff water was focused into this portion of the hillside. Open joints on the sandstone and siltstone outcroppings offered conduits for direct injection of water to the regolith/bedrock interface, promoting lubrication and instability.

Figure 14. Crown scarp March 28, 2005. Note water flowing freely over scarp surface.

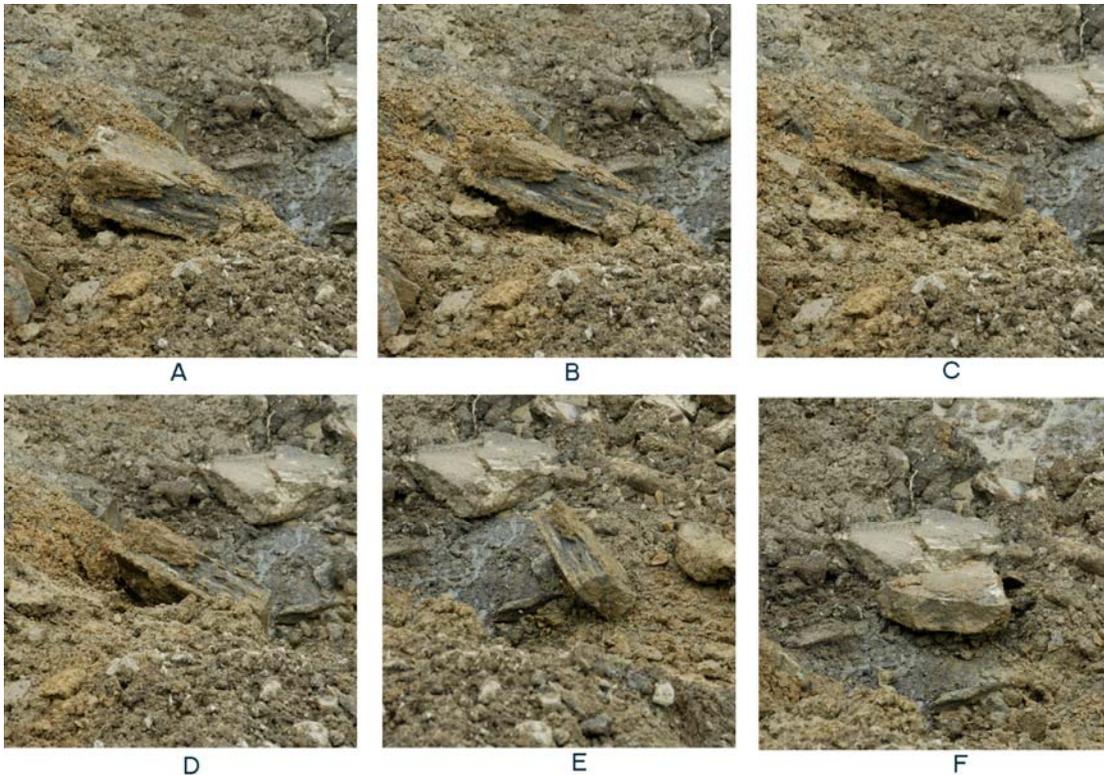
Although most of the movement on the slide occurred the morning of March 28, the slide continued to creep for several days. Trees, rocks, building debris, and soil continued to migrate to the edge of the 600-foot ledge and fall to the steeper slope below (Figure 15). The lower part of the slide (that is the part below the 600-foot contour ledge) continued to flow and creep toward the lake. Pressure ridges at the lake margin continued to inflate (Figures 8, 10). Trees that were initially only tilted fell. Experience has shown that this level of creep will continue for many months with slowing magnitude.

Figure 15. April 12, 2005. Rock fall due to continuing landslide creep

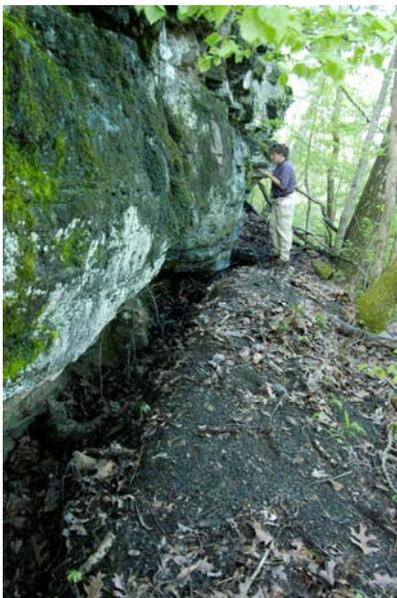
Adjacent to the top of the crown scarp we observed separation of the residuum from the base of the outcrop of the 720-foot contour sandstones as revealed by a shallow ditch in that location (Figure 16). Most of the separation appeared to have occurred well prior of the March 28 slide. We also noted that the poison ivy vines along a portion of the 720-foot contour outcrop adjacent to the slide were dead due to the roots being pulled apart and broken off. The condition of these vines suggested that the separation that unrooted these vines occurred last Fall or during the Winter (Figure 17). These observations suggest that the movement of the slope initiated well before the events of March 28. This prior movement might have also opened cracks in the soils providing a conduit for water.

Figure 16. Trench at base of 720-foot contour ledge.

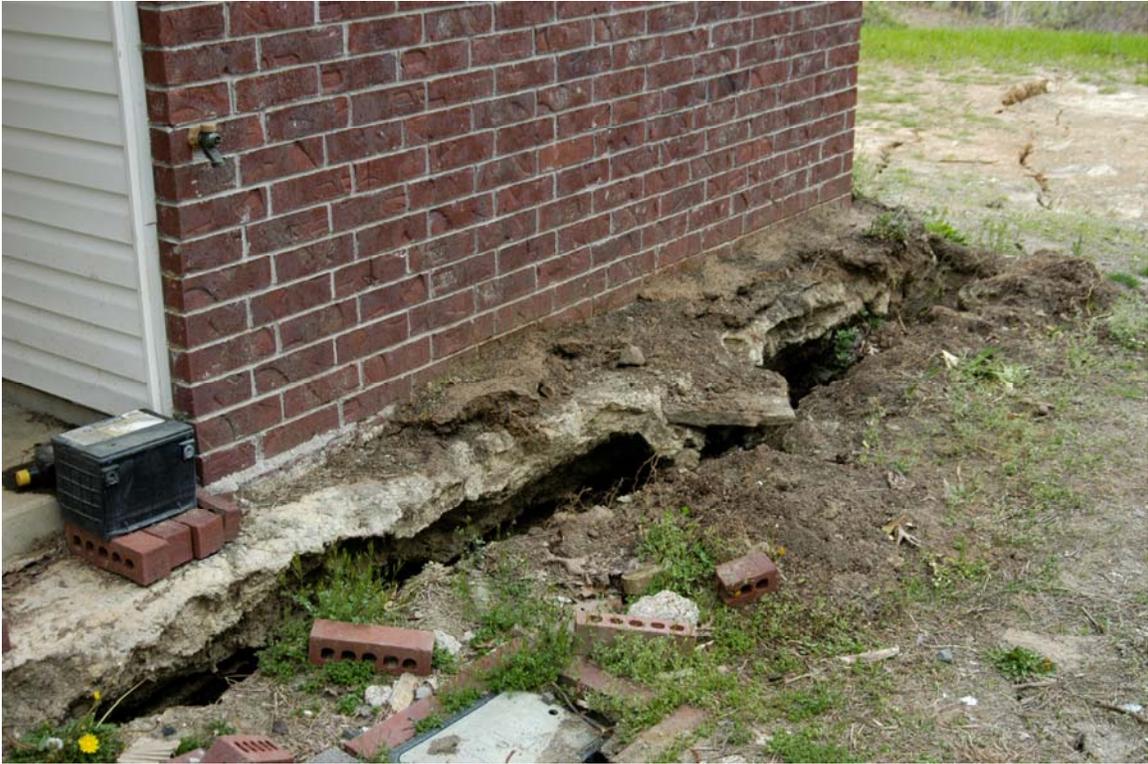
The Bradford house, except for the crushed garage and lost west wing seems to be relatively stable at the time of this report. We noted that the walls were still plumb and straight. The brick was generally undisturbed. In our initial examination of the house we noted one small old crack in the brick at the top corner of one window on the front of the house unrelated to the present activity. A visit to the site a month after the initial slide revealed a small fresh crack in the brick at the base of the front wall of the house. The ground surface to the south and east of the house has subsided several inches to a few feet leaving the footing exposed (Figure 18). This subsidence has compromised the underground utilities leading to and from the house. The house itself seems to be foundationed on or shortly above the 600-foot contour sandstone beds providing an island of stability. Whether this condition will persist, only time will tell. At the time of this report we have not yet had a period of protracted rainfall to test the stability of these features.

Figure 18. Surface subsidence on the east side of the Bradford house revealing its foundation.

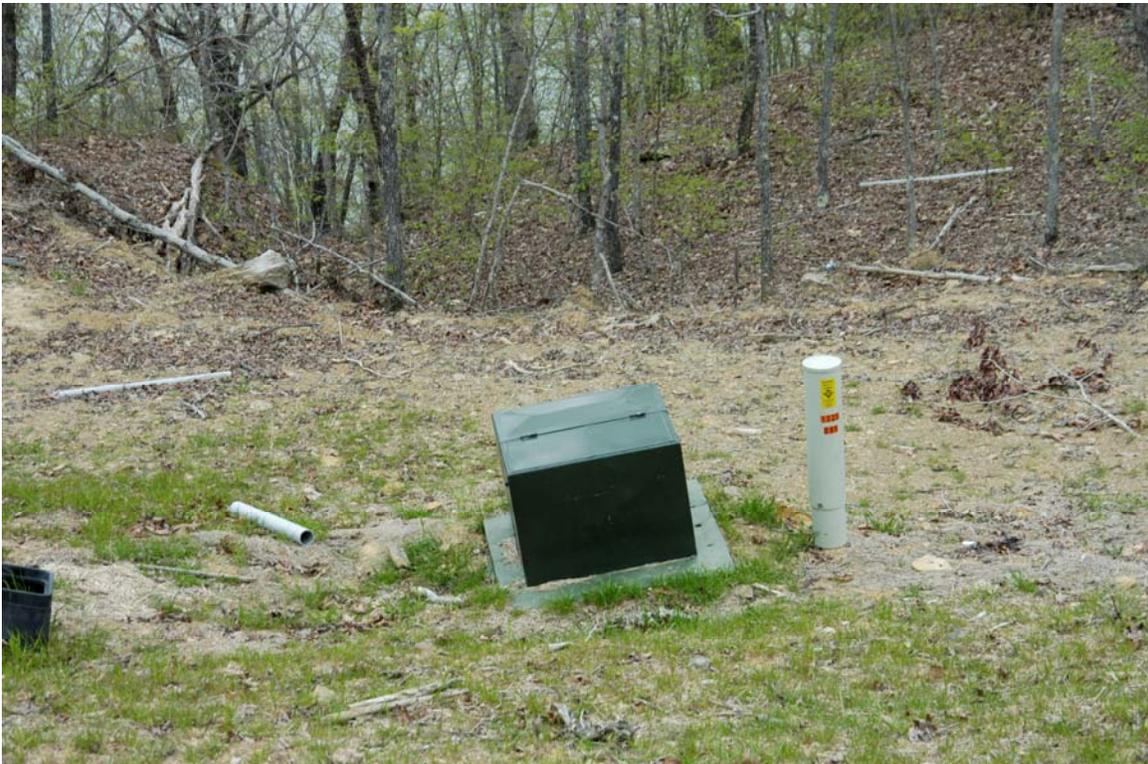
Figure 19. Phone and power boxes displaying effects of subsidence and displacement marginal to main slide area.

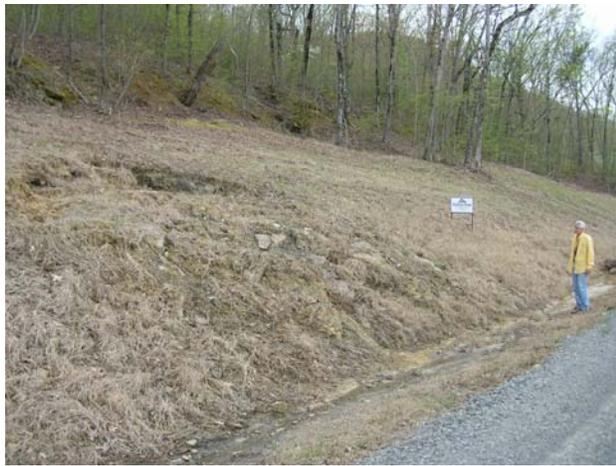
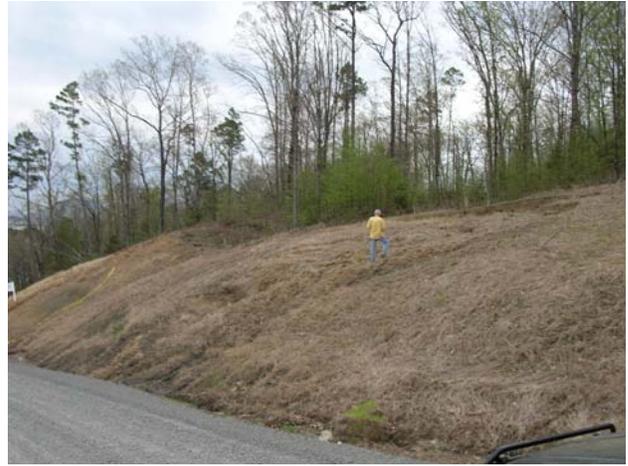
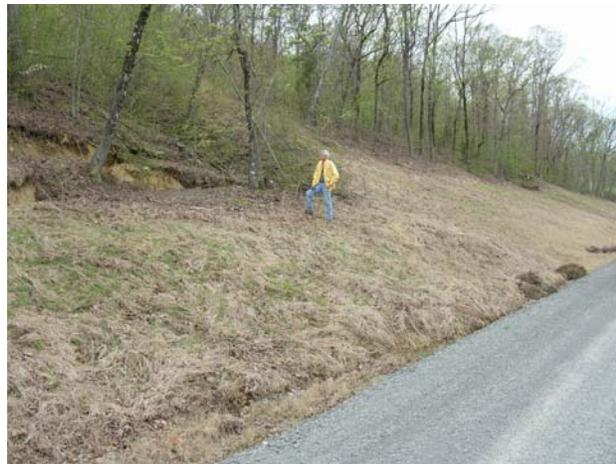
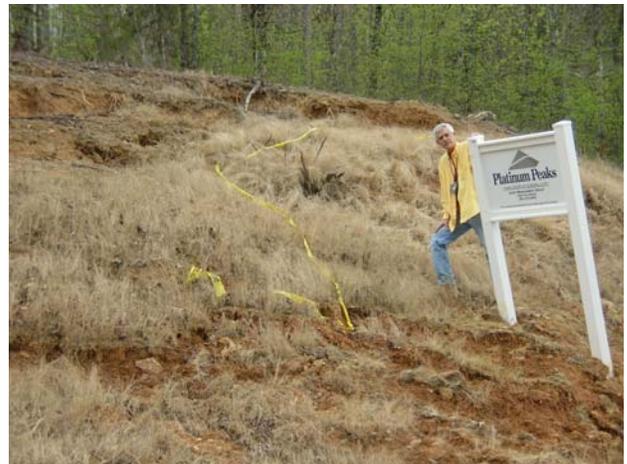
We noted 11 smaller landslides along the road leading to the Bradford house. We have no doubt that these slides were the direct result of the recent road building activity and the associated clearing of the forest to either side of the roadway. These slumps ranged from about 25 feet to 250 feet wide and about 20 feet to 100 feet toe to crown scarp (Figure 20). All of these unintendedly induced slumps were on the uphill side of the road. However, we did note that some cultural features normally expected to be level and or plumb deviated from the expectation downslope of the road suggesting wide spread slope instability (Figure 19). This hillside averages slightly less slope than the Bradford property, about 15 to 20 degrees. This area is under development at the present time. It is highly probable that additional modification or construction efforts on this hillside will induce more slope failure that will need to be addressed in non-traditional and creative constructional methodologies to be successful.

Figure 20. Small landslides on Platinum Peaks development along road leading to Bradford house.

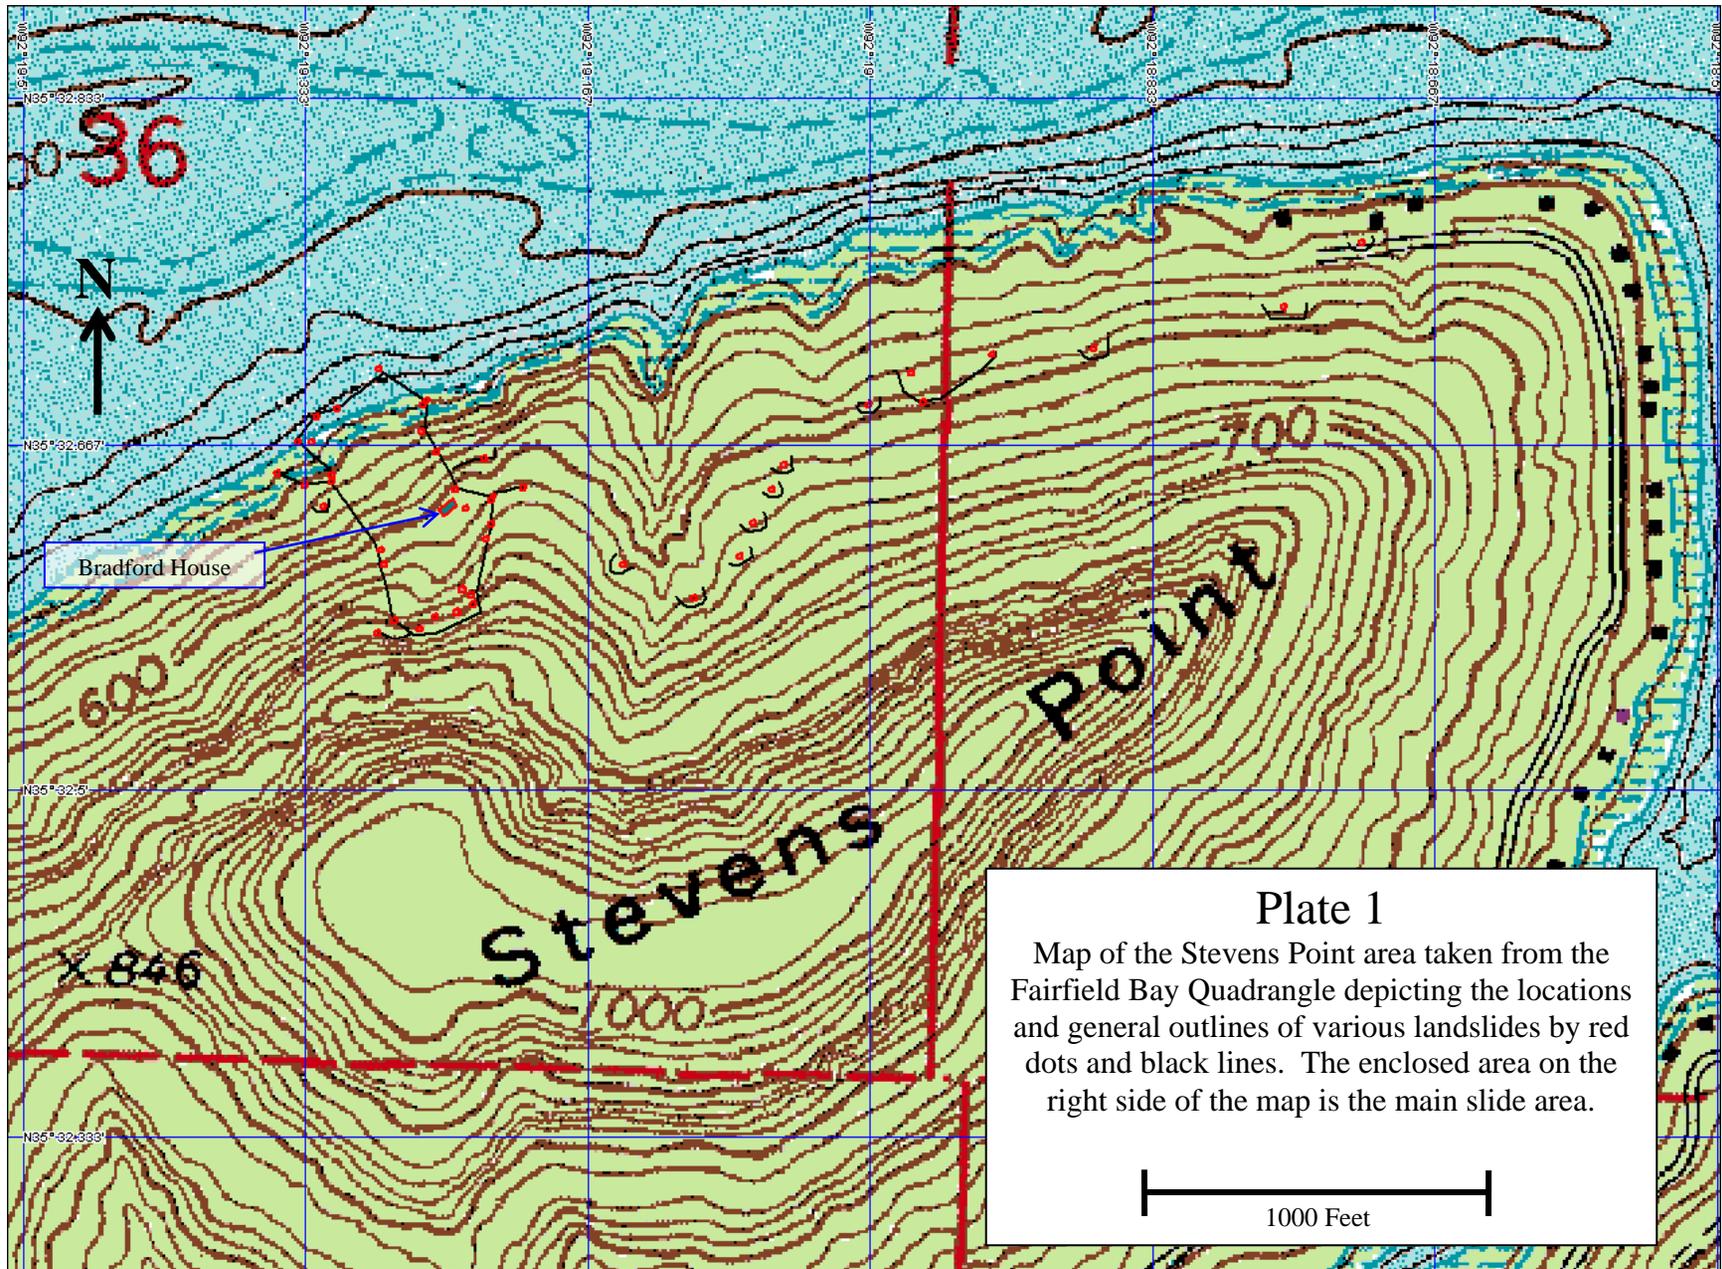
The slide area is over 700 feet long crown scarp to toe and 300 to 500 feet wide (Plate 1). The slide is divided in two major portions by the sequence of sandstones forming a significant ledge about midway down the slide area (just below the 600-foot contour). It

Plate 1
Map of the Stevens Point area taken from the Fairfield Bay Quadrangle depicting the locations and general outlines of various landslides by red dots and black lines. The enclosed area on the right side of the map is the main slide area.
