**PRELIMINARY REPORT ON THE IZARD COUNTY ROAD 70
KARST PROBLEMS (SINKHOLE COLLAPSE), IZARD COUNTY, ARKANSAS**

J. Michael Howard, Scott Ausbrooks, Angela Chandler, and Bill Prior
Arkansas Geological Survey
November, 2009

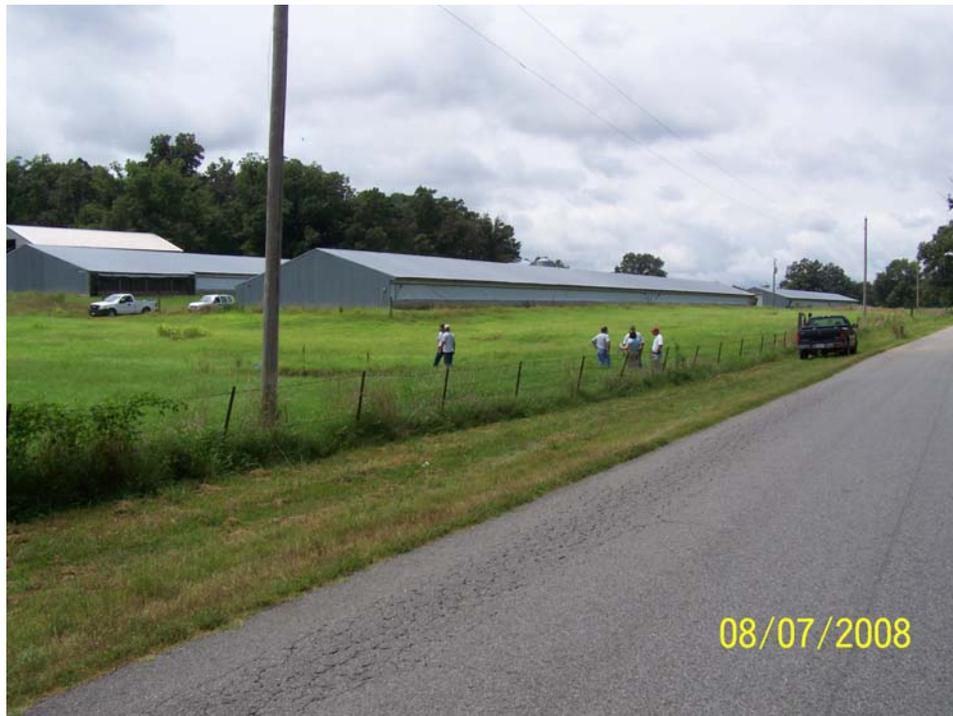
Sinkhole is in center of left field of view in pasture, adjacent to IZARD CR 70.
Looking west southwest.

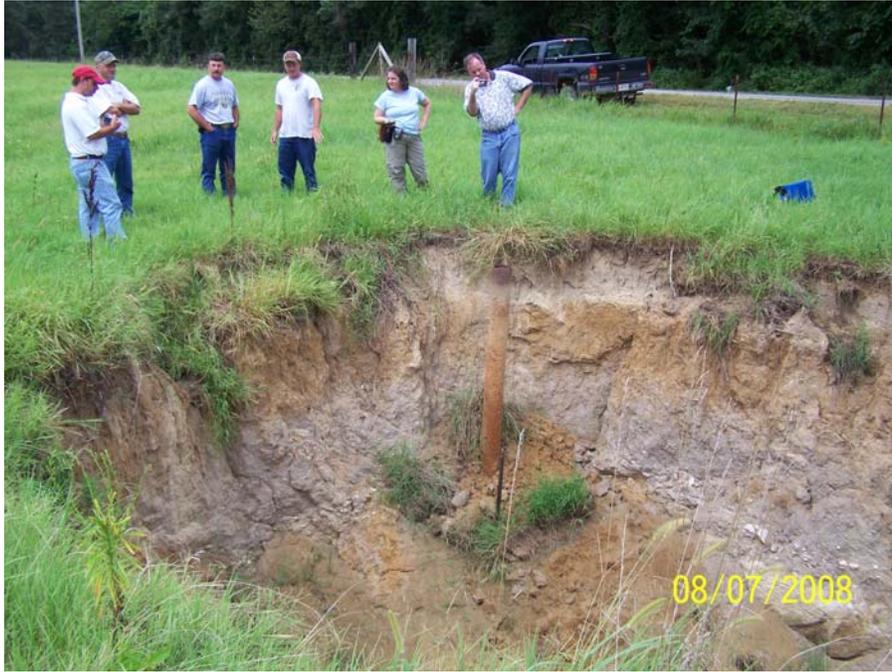
Note that in the picture below, no sign of grouting is present on the well casing.

Sinkhole formed around abandoned well bore, view looking northwest. Note soil horizon of ~6 feet and regolith below soil. Looking northwest.

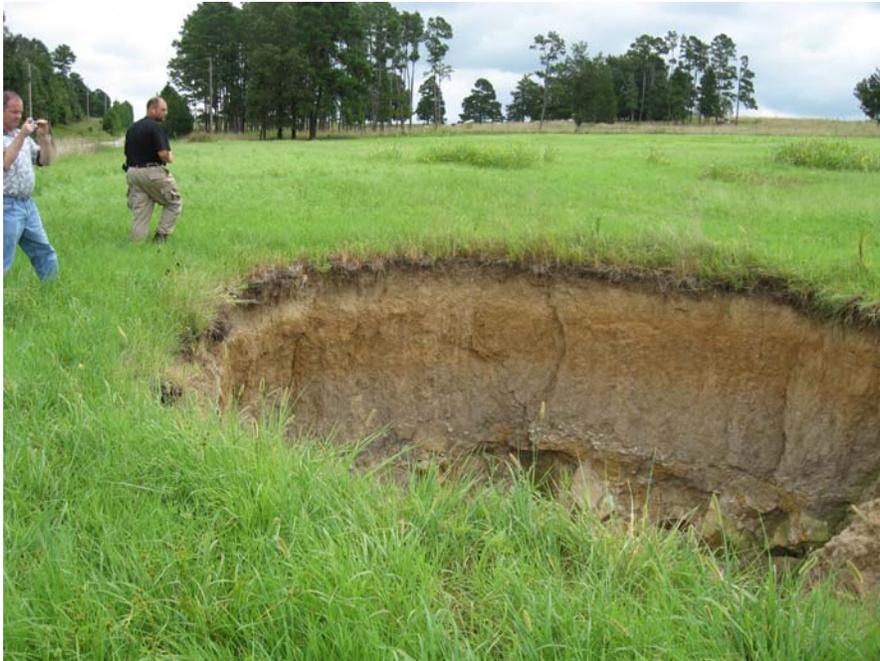
View looking east showing soil horizon – regolith contact.

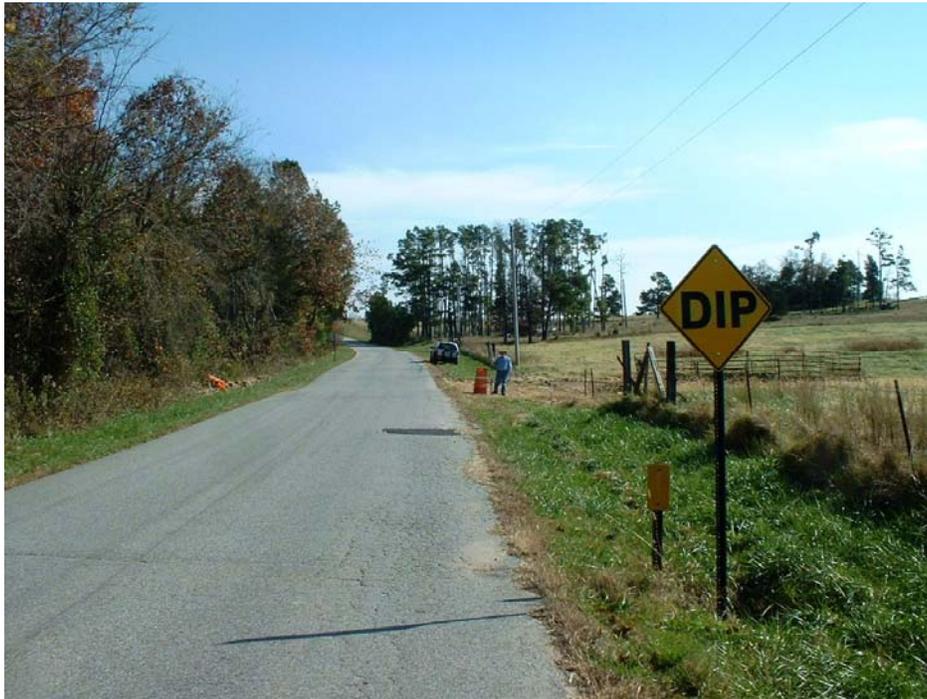
Drop in IZARD CR 70 is marked by Dip sign and orange barrel. Mr. Prior is standing adjacent to center of road down drop. Looking east.

Typically in the existing early situation of road collapse, county road maintenance personnel begin to either fill or pave over the existing recent subsidence. This can make the situation worse in the long run and is a waste of time, materials, and money. Since there is no apparent subsidence north of the present road location, there is time for county officials to contact local property owners to explain the situation and seek the right to relocate the road to the north, should the situation worsen. When the road is constructed, it should be built with proper sub-grade drainage (a culvert) so that water will not pond against the road bed on the south side of the road.

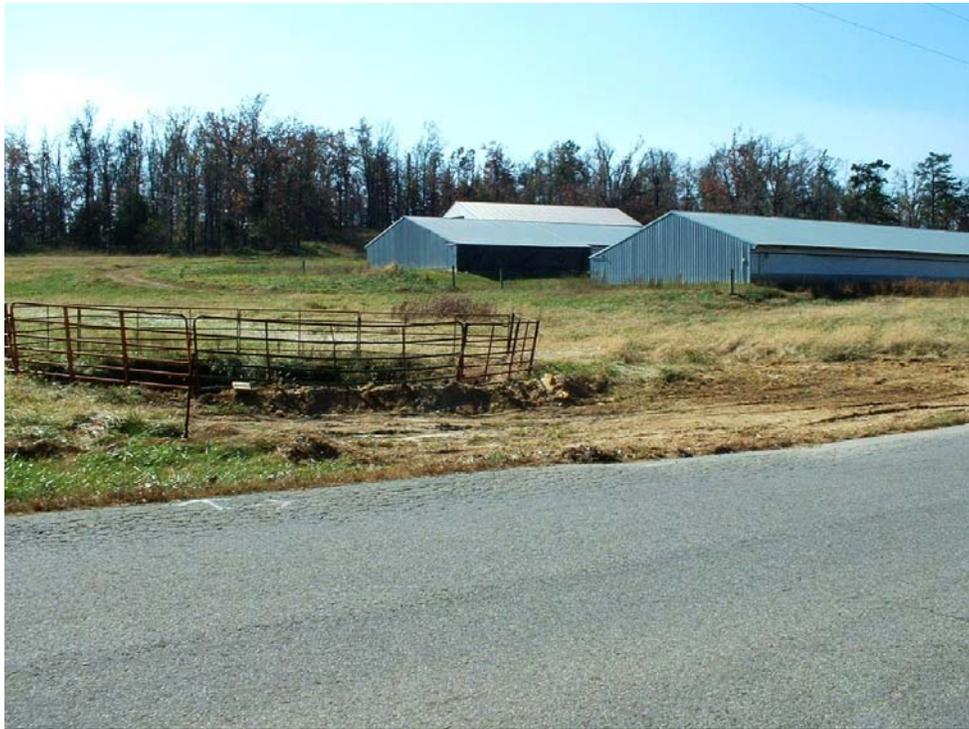
Ditch alteration and fence removal next to sinkhole. Note drainage direction sloping towards sinkhole, small berm, and fencing at edge of sinkhole. Looking southwest.

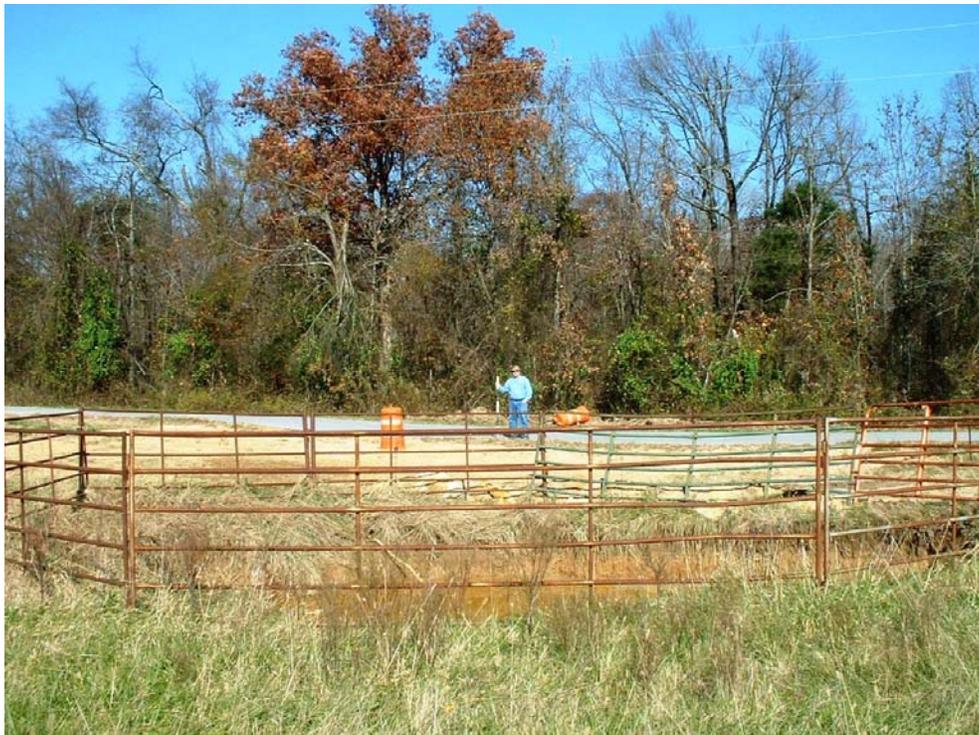
View across sinkhole, looking north towards the center of road collapse area.

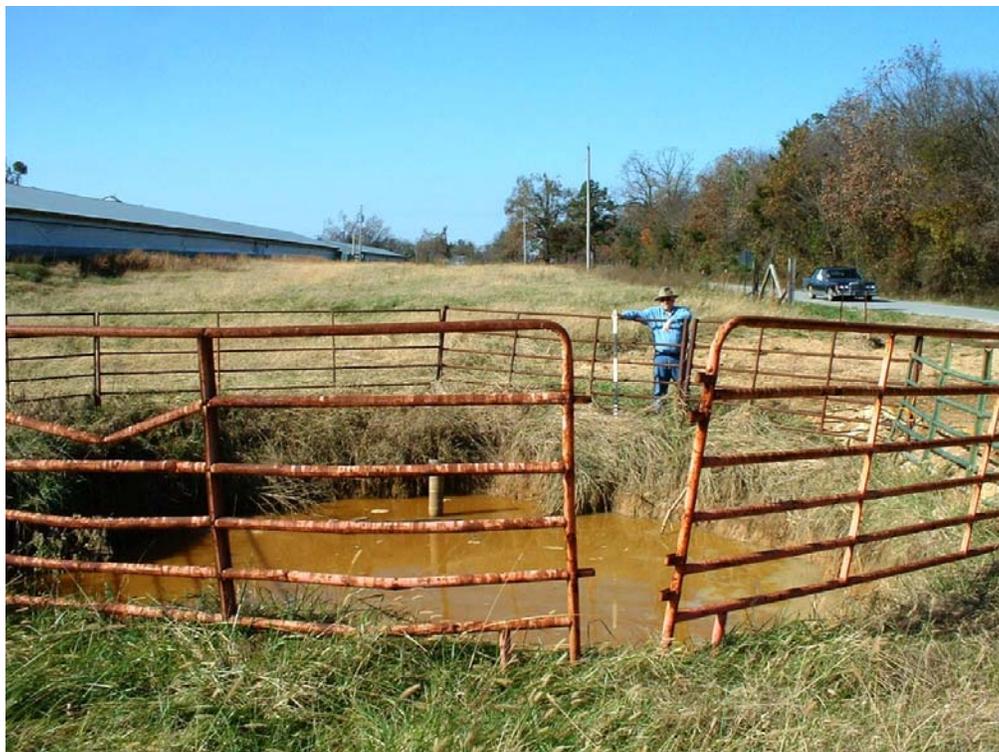
Water-filled sinkhole/collapse structure. Looking west.

However, it does appear that both wells on this site have penetrated a paleokarst feature, either enlarged joint sets or actual sediment-filled caverns or voids. Surging of water within this system due to heavy rain events caused the collapse of the well nearest the road first, just a week prior to the first visit in 2008. Heavy rains in October 2009 appear to have caused the subsidence of CR 70 into such a void or enlarged fracture system. It is not known which event or if either one affected the southern well site, only that it shows signs of subsidence and may potentially collapse with additional heavy rains to resemble the first sinkhole/collapse structure. Investigations in the woods north of CR 70 during both visits did not indicate any additional subsidence downstream from the study area.

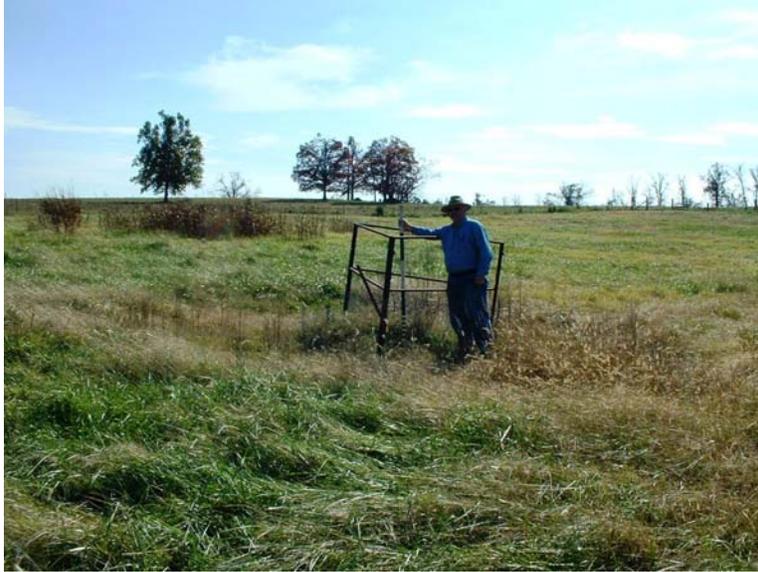
Subsidence around second well is about 24 feet in diameter. Farmer has marked this capped casing to keep from disturbing it when cutting hay. Looking south.

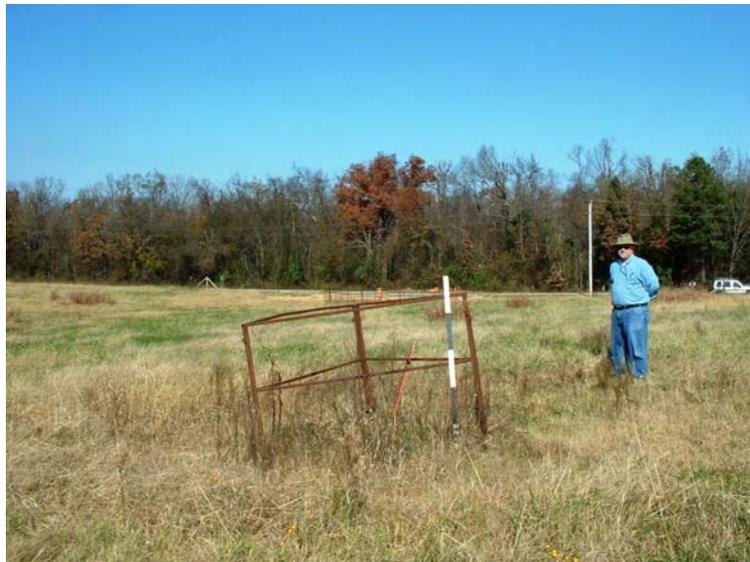
Relationship of 2nd subsidence to sinkhole. Bill is standing on rim of subsidence structure. Looking north.

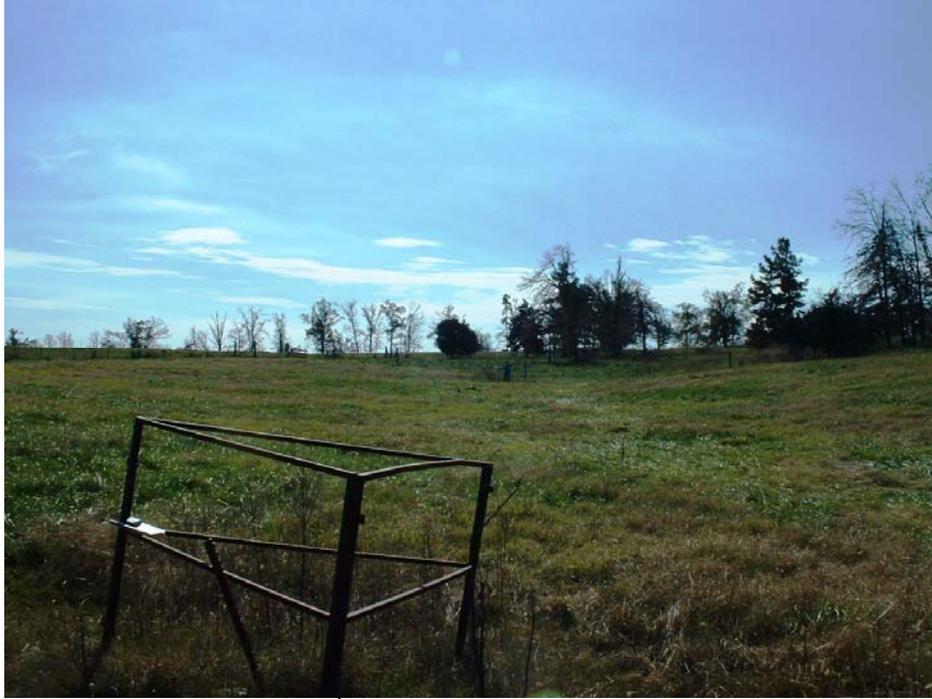
View up drainage from 2nd collapse structure. Bill is standing on Everton outcrop or knocker near fence line, center of image. Looking south.

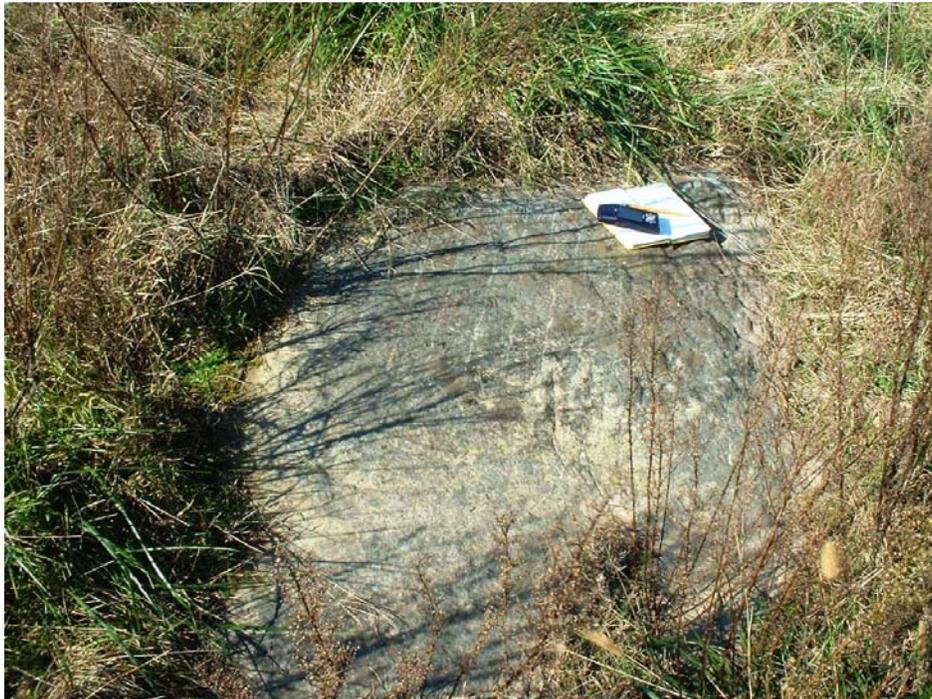
Limey sandstone of Everton Formation in outcrop. Lines are possibly scratch marks from hay rake.

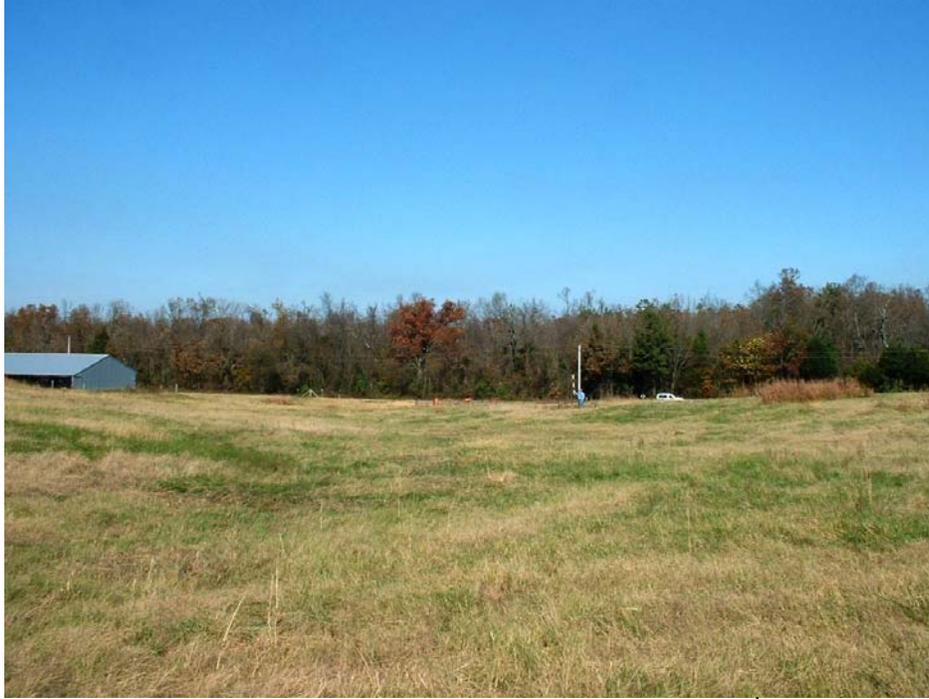
View down drainage from Everton exposure. Bill is at 2nd subsidence. Sinkhole fencing and orange barrels along CR 70 are visible. Looking north.
