# A CASE HISTORY OF A MAJOR LANDSLIDE ON CROWLEY'S RIDGE, VILLAGE CREEK STATE PARK, ARKANSAS

by  
John David McFarland, III and Charles G. Stone  
Arkansas Geological Commission  
Little Rock, Arkansas

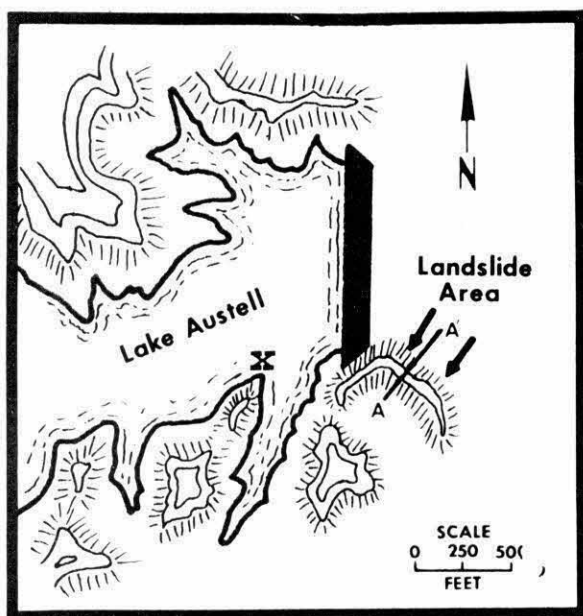
**FIGURE 1** — Location map for Village Creek State Park landslide. A—A' is line of Figure 4 topographic profile. X marks the location of the borrow pit from which clay was taken for the dam core and bank blanket.

The borrow pit for the clay used for the dam core and bank blanket was developed into the toe of the ridge marked by an X on Fig. 1. Although the pit was bermed on the ridge side, the removal of the natural slope along with the demonstrated propensity for landslides in the immediate area indicates another potential danger. If a sizable portion of the ridge were to catastrophically glide into the lake, water could be swept over the dam resulting in erosion of the dam, abutments, or both.

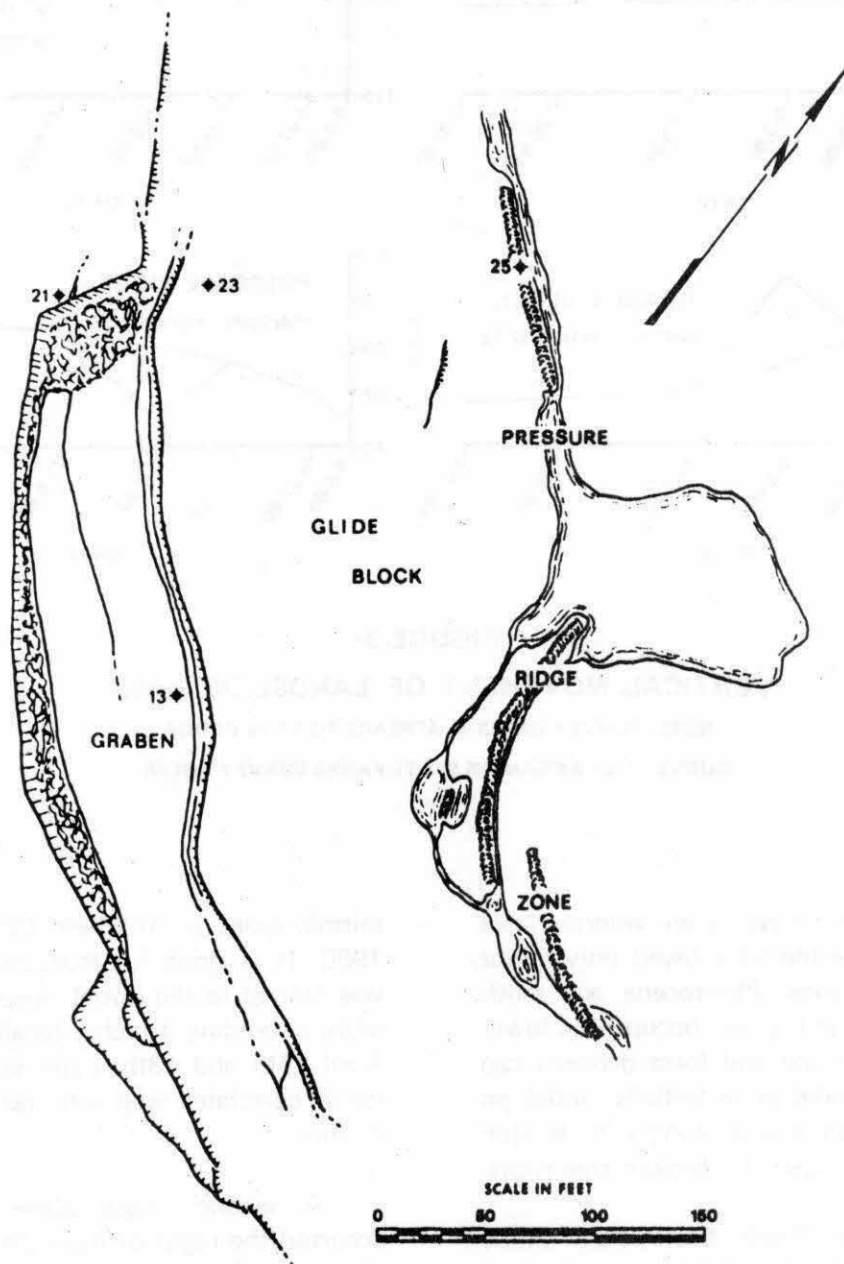
FIGURE 2  
VILLAGE CREEK STATE PARK LANDSLIDE AREA

areas: a pressure ridge zone, a glide block, and a graben (Fig. 2). The area of pressure ridges is presently at the toe of the hill and extends for a short distance out onto the valley floor. In this area many indications of uplifted ridges of various lengths subparallel to the long axis of the block glide are evident. Where the surface was compressed, shallow roots of the trees were folded and forced out of the ground and in some cases broken. Numerous holes and short cracks initially seen throughout this area seemed to be the result of these buckling roots. Cracks in the ground surface seemingly unrelated to tree roots were seen only at places where the forest floor litter was thin or nonexistent. Most of these cracks trended subparallel to the long axis of the slide. Plants on the crests and troughs of the pressure ridges showed little indication of the dramatic activity they had undergone; whereas trees on the flanks of these ridges were tilted and in a few cases had fallen.

One hundred and fifty feet or so up the slope from the zone of pressure ridges a graben feature is developed. The graben is about 400 feet long and 50 to 90 feet wide. It shows a maximum vertical displacement of 12 to 18 feet on the downhill side and about 25 to 35 feet on the uphill side. Tension cracks with minor displacement extend from each end of the graben resulting in a total main scarp length of 500 - 550 feet. One major block, partially split by a transverse crack has collapsed into the graben along with numerous secondary blocks (Figs. 2 and 4). The main block formerly was the crest and part of the slope of the hill. Trees that were

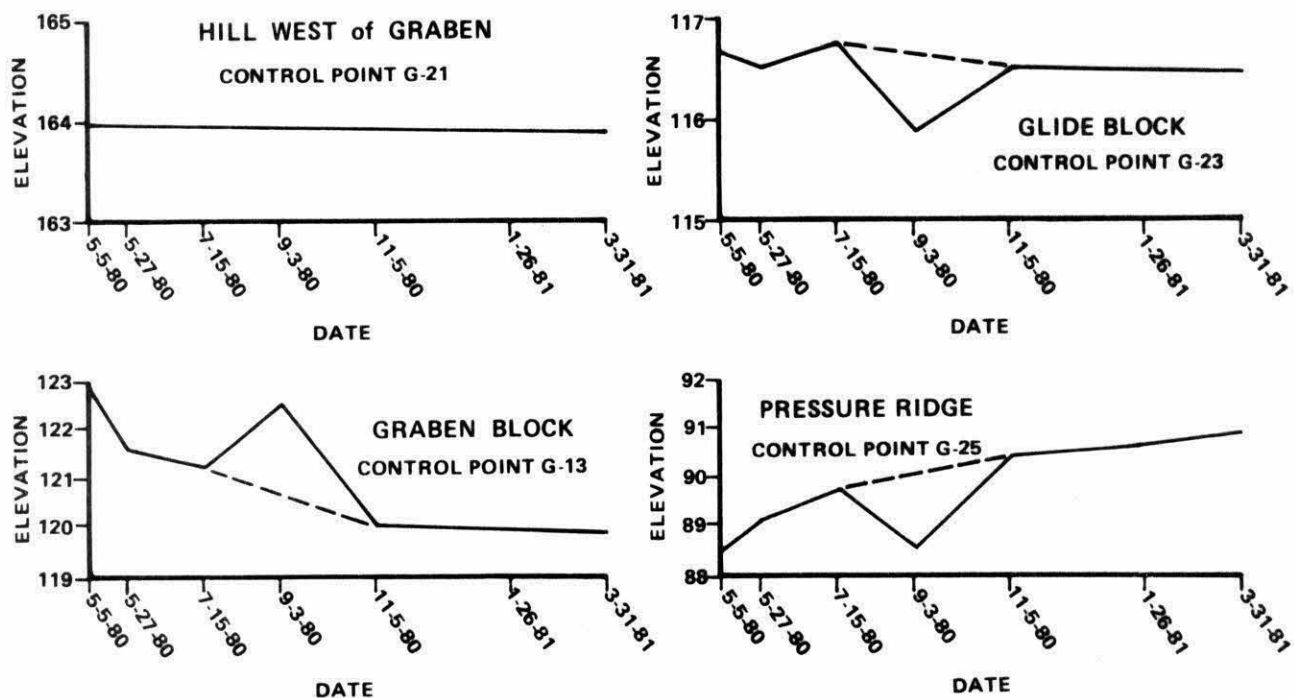
**FIGURE 3**  
**VERTICAL MOVEMENT OF LANDSLIDE AREA**

NOTE: SURVEY ON 9-3-80 APPEARS TO BE IN ERROR  
(SURVEYS BY ARKANSAS STATE PARKS SURVEY CREW)

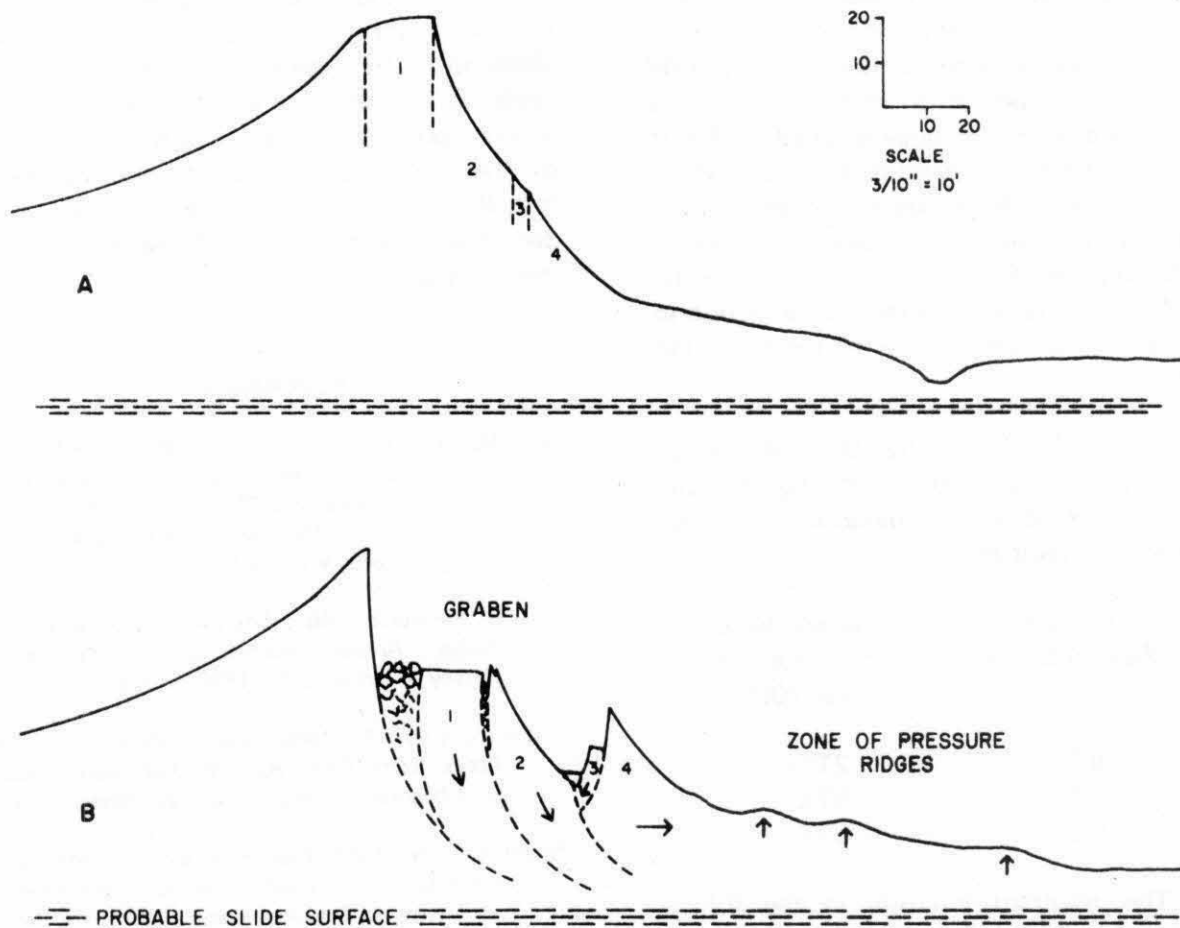
**FIGURE 4**

- A. This topographic profile of the landslide area is taken from Figure 1 (A-A') and indicates what the hill looked like before the landslide. The dashed lines show the boundaries of the major blocks involved in the slide.
- B. This idealized cross-section is a construction from the same profile as "A" modified per the authors' field observations. The horizontal displacement of block 4 as shown here is about 17 feet. The depth to slide surface was based on the cross-sectional areas of these two models. Arrows indicate direction of movement for each block.
