INFORMATION CIRCULAR 31

LANDSLIDE FEATURES OF CROWLEY'S RIDGE

John David McFarland

Little Rock, Arkansas  
1992

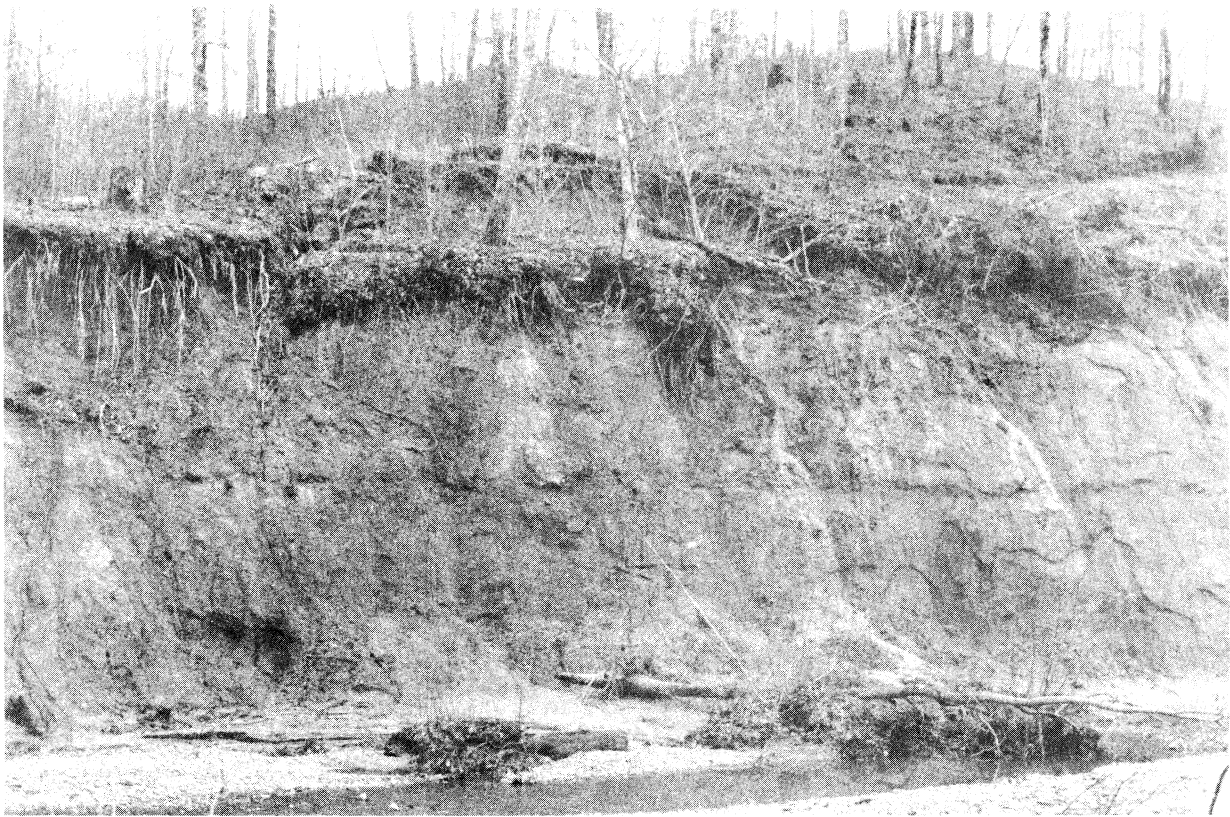
Along Copperas Creek (Site 15) a streamside bench was created by this foundering process early in the year (Figure 4). A 5-foot silt interval from beneath the vegetation mat failed and flowed over the underlying clayey, gravelly, silts into the creek some 20 feet below. The small trees, bushes, and other plants were lowered down as a single unit with its root mat intact. By summer this 10x25 foot bench looked as if it had been there for at least as long as the trees. The failed silt in the creek bed had long since washed away leaving no local trace. The resulting bench looked quite similar to other "stream-cut" benches near at hand. A slightly larger bench is developed a few yards upstream and at the same horizon. Is this other bench stream cut or a flow-failure/surface-foundering result?

**Figure 4.** One of the Site 15 flow landslides. The vegetation mat atop the displacement site settled up to five feet as the underlying silts flowed over the underlying bank and into the creek below. Note that there is no displacement of the underlying sediments. Traces of the failed material can still be seen at the surface and base of the stream bank.

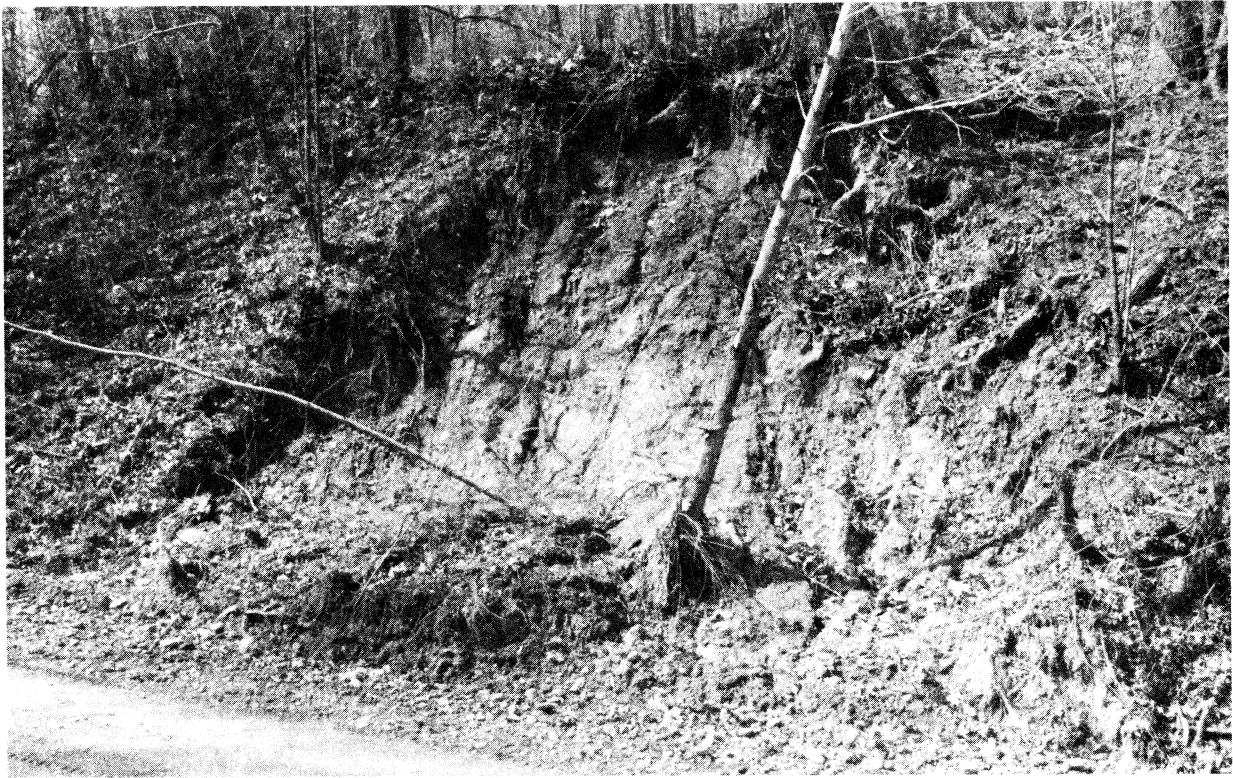
**Figure 5.** A typical and commonly seen road side rotational slump landslide. Most of the failed debris has been removed by local road crews.

Most roadside failures observed were rotational slumps (figure 5). These usually involved just the banks of the road cut. The most general outline of these slumps was a near equidimensional one although long, relatively low displacements occurred in several places. The near equidimensional slumps came in various sizes but all tended to be slightly higher than the feature was wide at the base. Usually the main scarp was highly arched and generally formed a continuous surface. The long, low, roadside rotation blocks extended laterally several times their height. All these roadcut rotational slumps were generally shallow and usually observed to displace only the material between the road bed and the lip of the roadcut, a distance of 5 to 25 feet. Shortly after failure the local road crews would

remove that part of the slump that intruded onto the road leaving a small fresh scarp at the top of the bank as the only indication of displacement. Displacements were usually only a few inches to a few feet and were observed to become reactivated after significant rainfall. Trees up to 18 inches in diameter were seen displaced by a few of these slumps suggesting long-term stability. In general the tilt of tree trunks was not an obvious indication of recent movement. Trees often grow at odd angles or shift their orientation along these steep banks and slopes due to incipient wind loads, light direction (breaks in the forest canopy), disease, human activity, and loss of supportive soils around their root systems during the life of the tree.

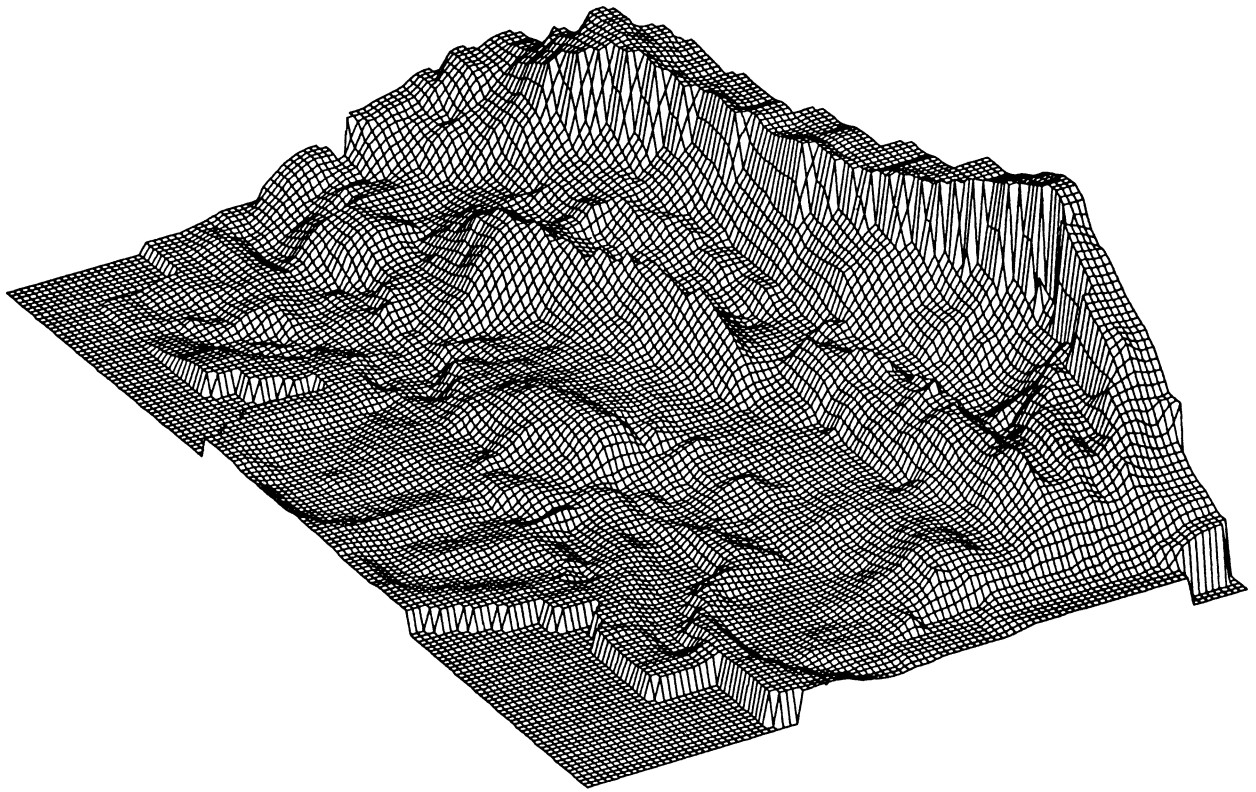
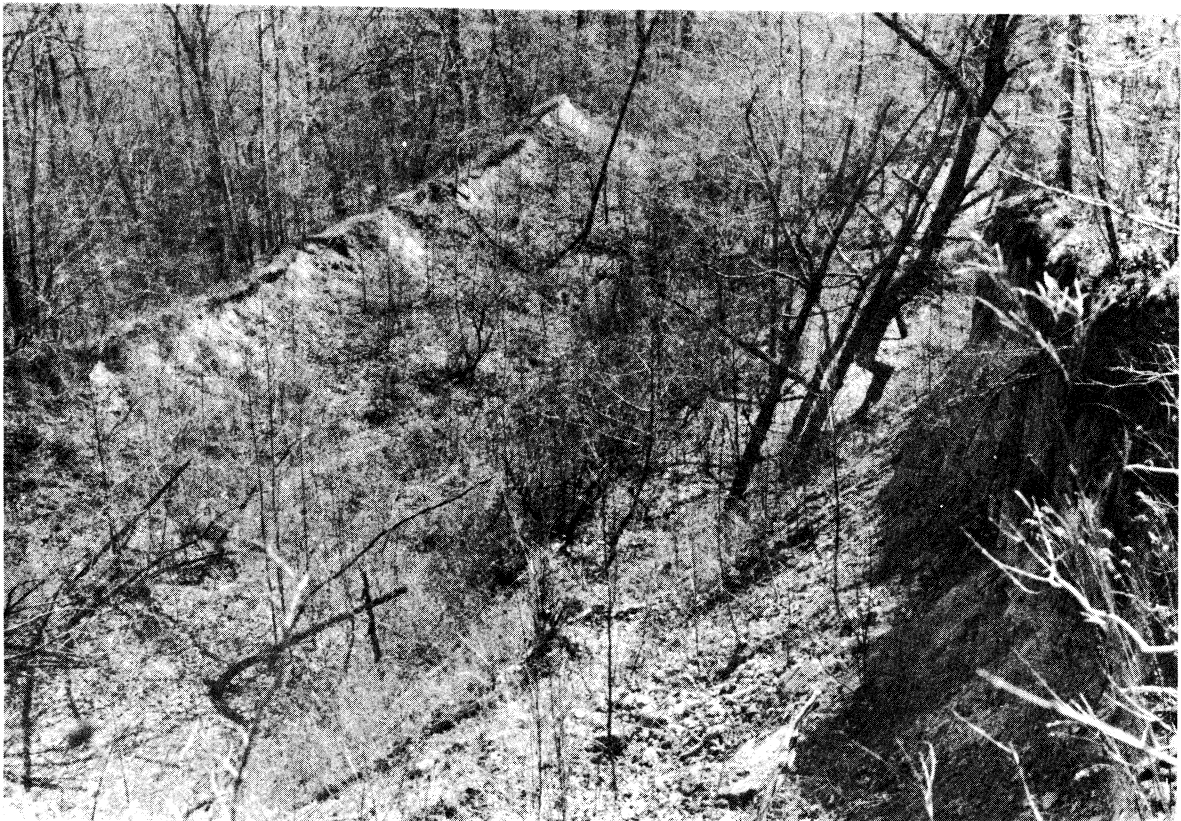
Block glide displacements (Simonett, 1968) seem to be a rare form of landslide on Crowley's Ridge. Only one example of this form was observed and there is little doubt that it is the result of artificial conditions. The initial displacement of the Lake Austell landslide (site 46a, figure 6) occurred in the spring of 1980 and was first ascribed to a shallow seismic event (Lowman, 1980; Zollweg, 1980) but later investigations dismissed this suggestion in favor of the failure of a confined strata due to increase pore pressure (McFarland and Stone, 1982; Dow and Schweig, 1990). This feature is developed on a northeast facing slope that forms the south abutment of Lake Austell Dam. Lake Austell is an 1100 acre-foot lake in Village Creek State Park near the southern boundary of Cross County. It was constructed in the late seventies and first filled in 1979. The slide developed in two phases: one in 1980 and the other at least a year and a half but not more than 48 months later. (Note: Dow and Schweig [1990] indicated a failure of the second block within a few days of the first block. This is in error.) In the first phase a large coherent block slid on a near horizontal plane out into the valley floor pushing up a series of pressure ridges. A graben developed behind this laterally translated block that vertically displaced the crest of the ridge spur some 40 feet in places. The second phase of the feature may have been initiated during this time but displayed no discernable offset for at least the next 20 months. However, by 48 months after the initial failure, another equally large block was observed to have moved in essentially the same fashion, extending the main scarp to within a few 10s of feet from the foot of the dam.

**Figure 6.** A) Digitized image of the Lake Austell landslide at Village Creek State Park. This 3D surface plot was created by digitizing the detailed contour map of Dow and Schweig (1990) and using the program SURFER from Golden Software. The view is from the north. B) The graben of the Lake Austell landslide. The picture was taken from the top of the crown scarp looking southeast.
