**PRELIMINARY REPORT – BLACKJACK LANE LANDSLIDE
ON GAITHER MOUNTAIN, SW OF HARRISON,
BOONE COUNTY, ARKANSAS**

by J. Michael Howard
Arkansas Geological Survey
November 2009

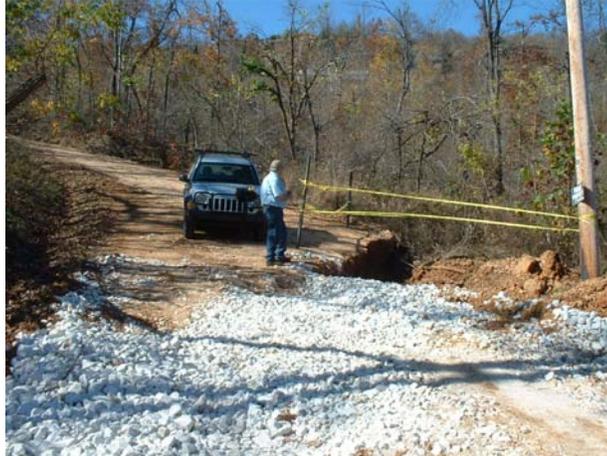
Image 1

West edge scarp crossing Ridge Court Road. Down drop of slide to right (north) of 18 inches initially. Now looks more like 24 inches. Latitude: 36.128134, Longitude: -93.20113.

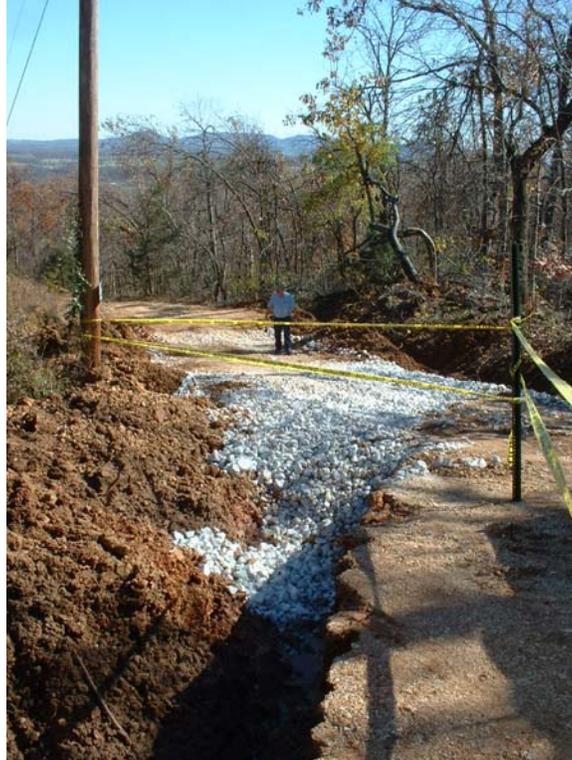
Image 2

View looking east down slope from west scarp line on Ridge Court Road. Note hummocky nature of road below scarp due to colluvium creep.

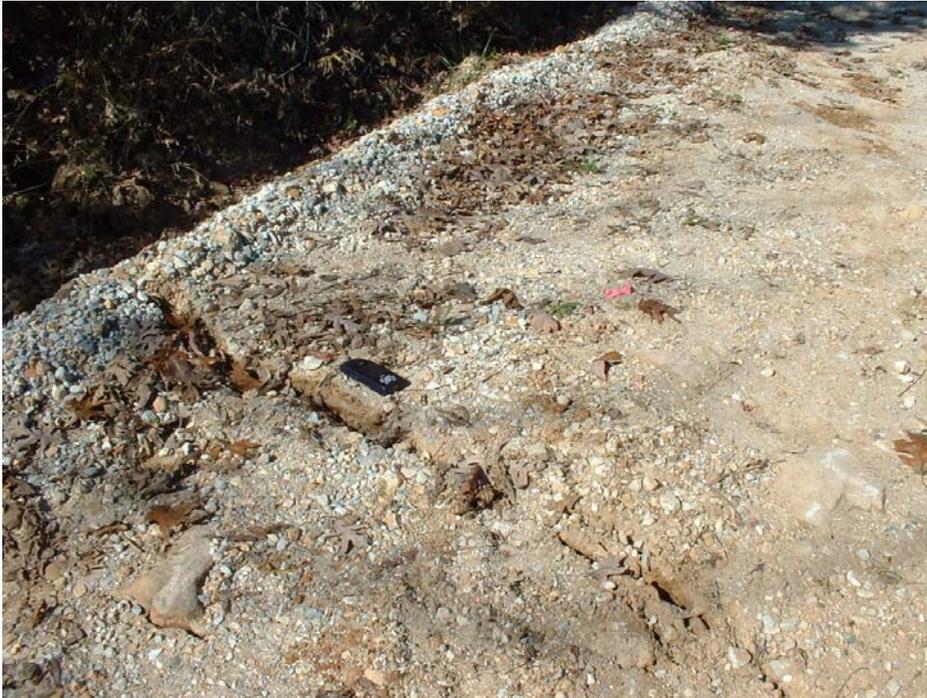
Image 3

“Hump” and crack in road near Pin #3 on Blackjack Lane. Tensional crack trends N80°E and is down dropped ~1 inch to the south. Latitude: 36.18156, Longitude: -93.19998.

- *Why is the road humping up?* From the existing survey data, it does not appear the road is humping up, but instead that large rocks buried in the road are moving

- slower than the finer grained sandy soil surrounding them. Everything is moving to the southeast. The end result makes it look like the rocks are moving upwards.
- *Is Mr. Paul Hinkson's home in danger?* After visiting his home, finding no signs of ground disturbance, and examining the position of his home relative to the position of the old landslide (see Appendix 3), it appears his home is in no danger.

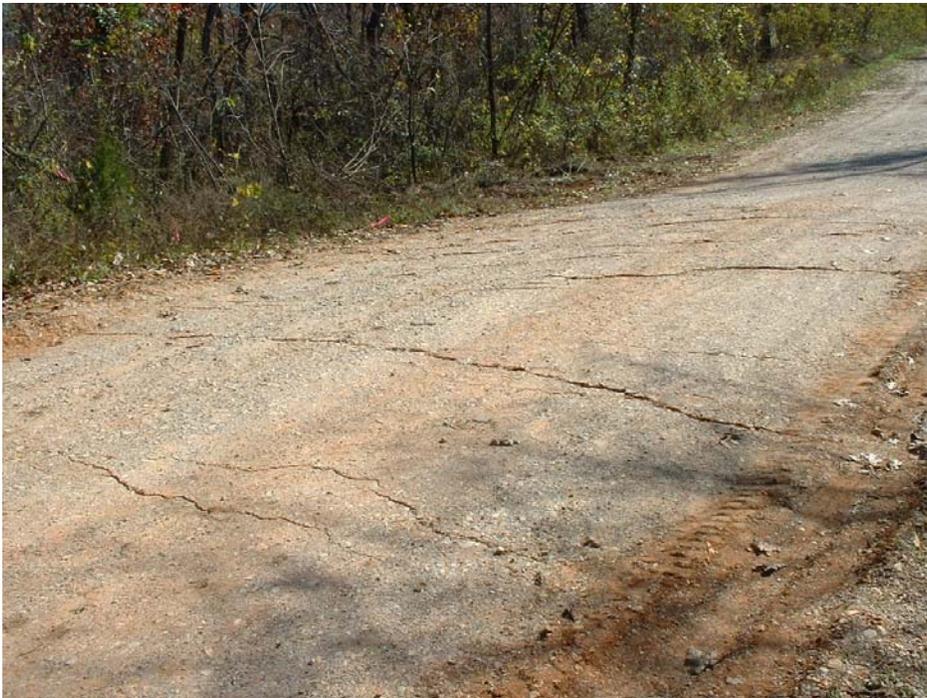
Image 4

Set of 6 sub-parallel tension cracks trending N130°W in Blackjack Lane. Latitude: 36.18256, Longitude: -93.19981.

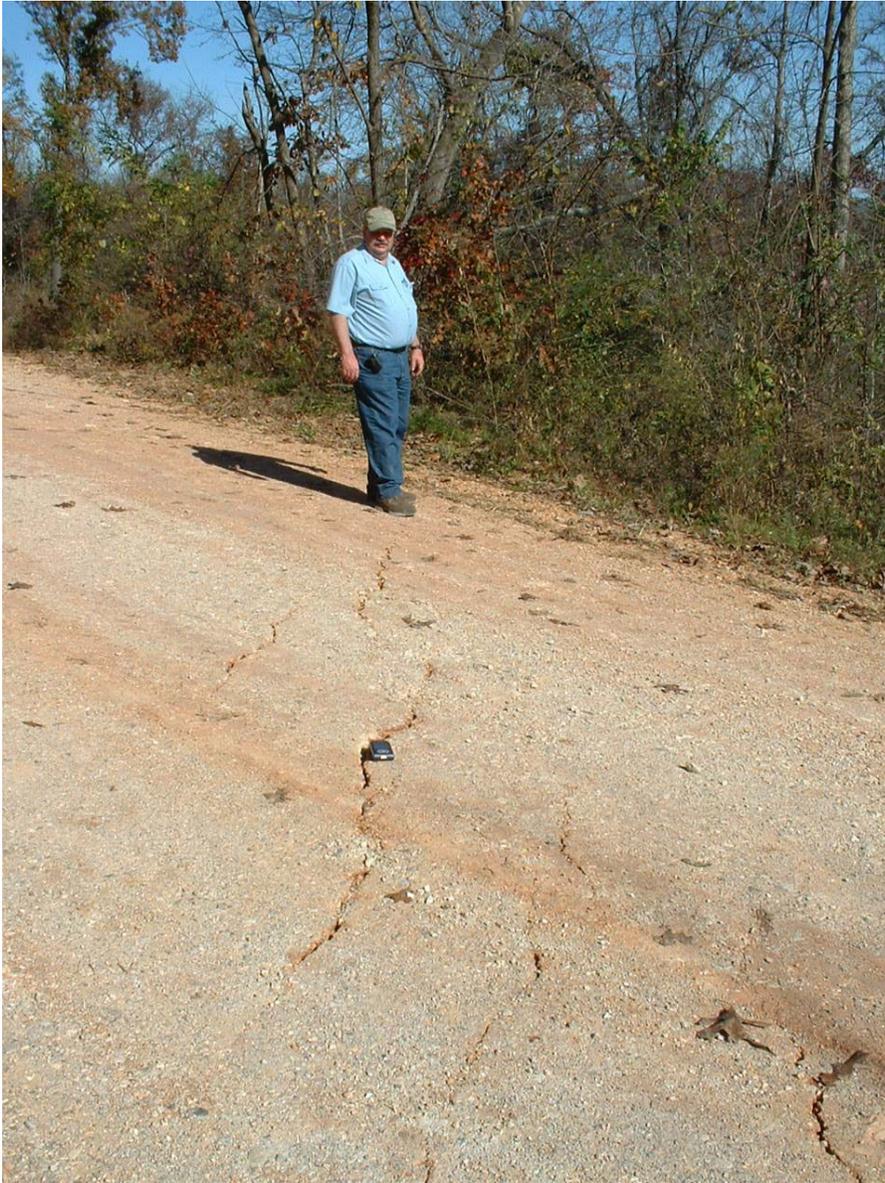
Image 5

Sub-parallel tension cracks, slight down slope offset to the southeast, trending N130°W, near crest of rise, northeast edge of slide area, Blackjack Lane. Latitude 36.18281, Longitude: -93.19977.

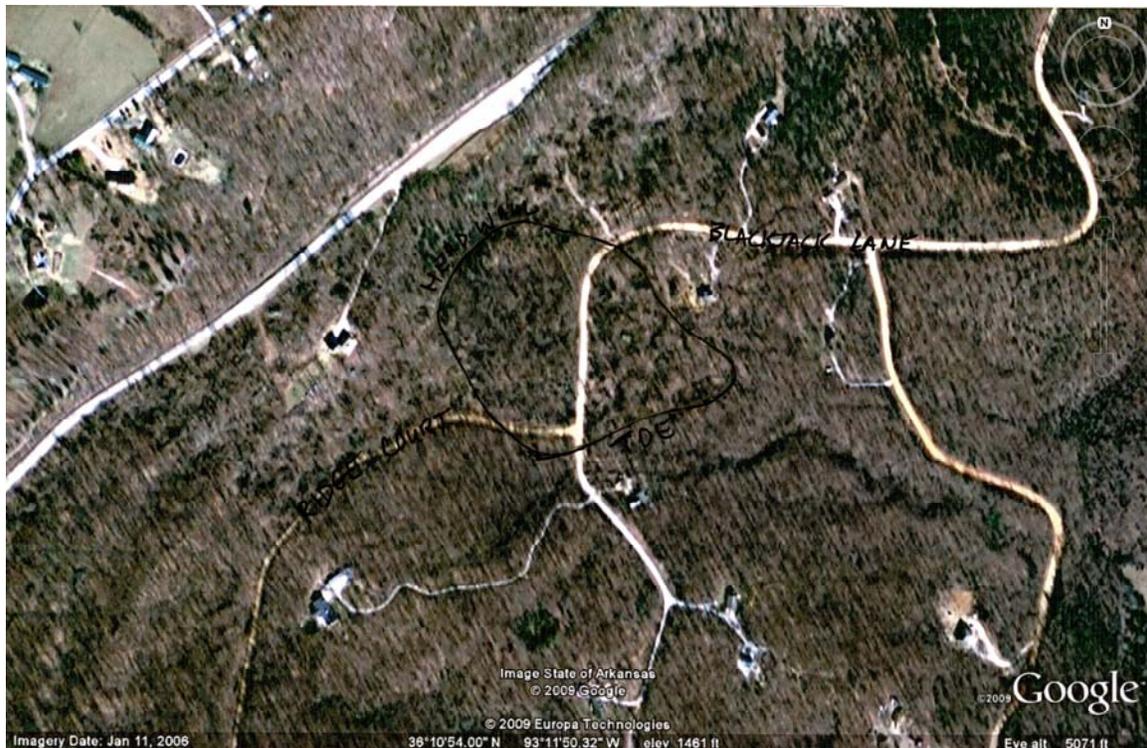
Google earth image – Outline of old landslide is drawn and headwall area and toe of landslide are labeled, along with roads. North is to the top.

Google Earth imagery (January 11, 2006) displays both the existing road system and a markedly different ground and vegetation pattern within the area investigated. This area of hummocky ground on the image represents an old landslide. The area was outlined on the accompanying GE imagery and the roads labeled (Appendix 3, Google earth imagery plot). The old landslide outline was transferred to the Gaither topographic map (Appendix 3, Topographic map plot), and it was determined that the old slide is approximately 20 acres. Blackjack Lane trends north-south across the old landslide and Ridge Court trends east-west across the west edge of the landslide. It is undetermined as of this date whether the entire old landslide or only a portion of it is moving.

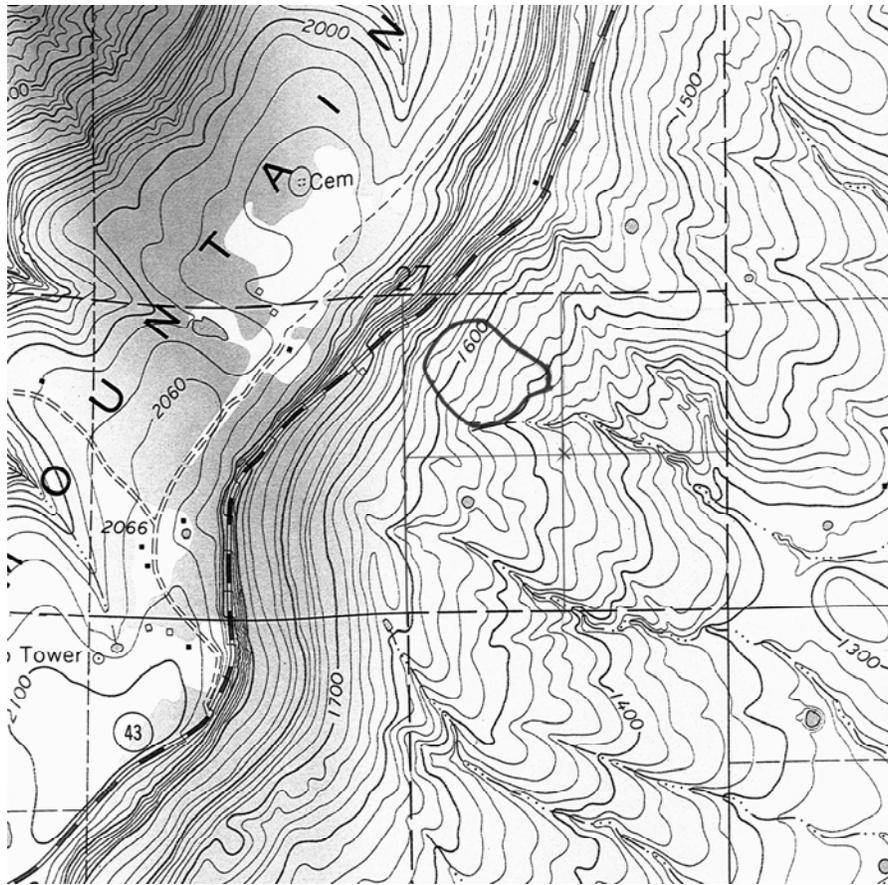
Topographic map – Plot of position of old landslide on USGS Gaither 7.5-minute topographic map. North is to the top.
