**PRELIMINARY REPORT ON THE IZARD COUNTY ROAD 70
KARST PROBLEMS (SINKHOLE COLLAPSE), IZARD COUNTY, ARKANSAS**

J. Michael Howard, Scott Ausbrooks, Angela Chandler, and Bill Prior
Arkansas Geological Survey
November, 2009

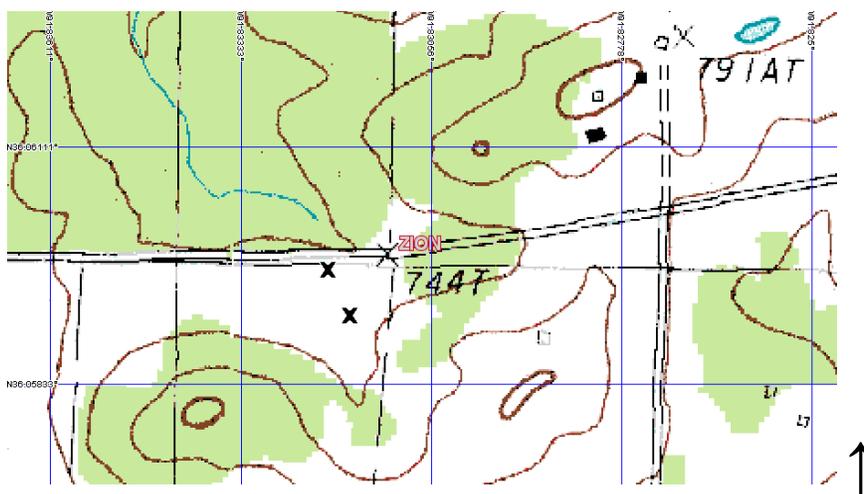
The northern **X** marks the site of the first noted sinkhole/collapse structure and the southern **X** marks the site of the second water well with subsiding ground surrounding it. Arrow points North. DeLorme 3-D Topo software image, Zion quad.
