INFORMATION CIRCULAR 31

LANDSLIDE FEATURES OF CROWLEY'S RIDGE

John David McFarland

Little Rock, Arkansas  
1992

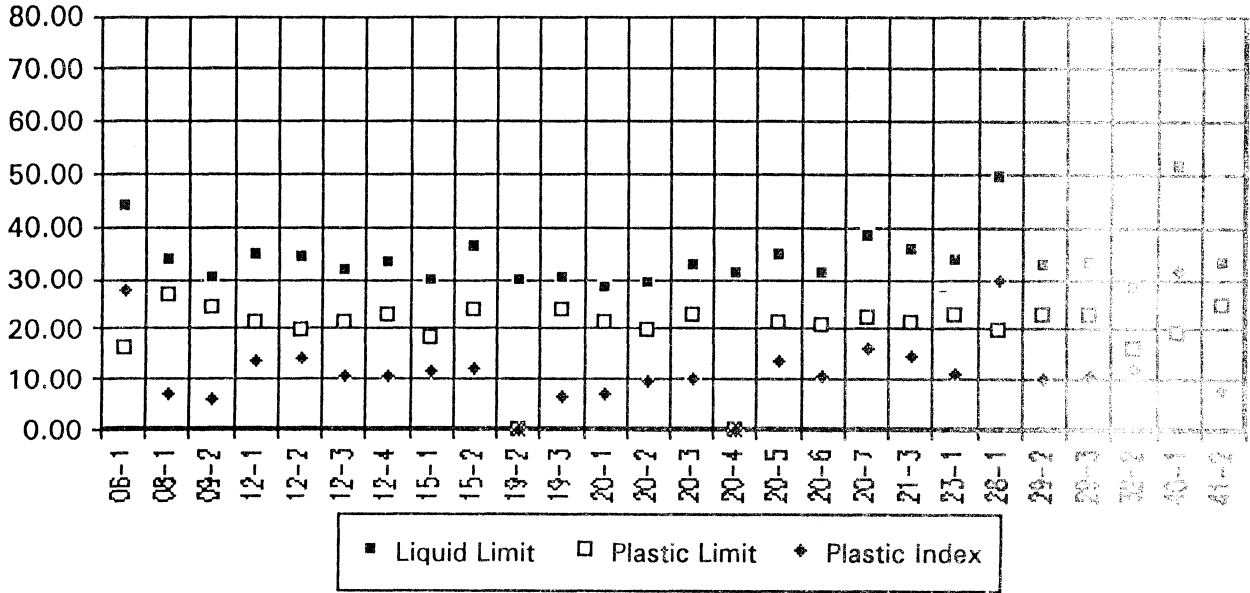
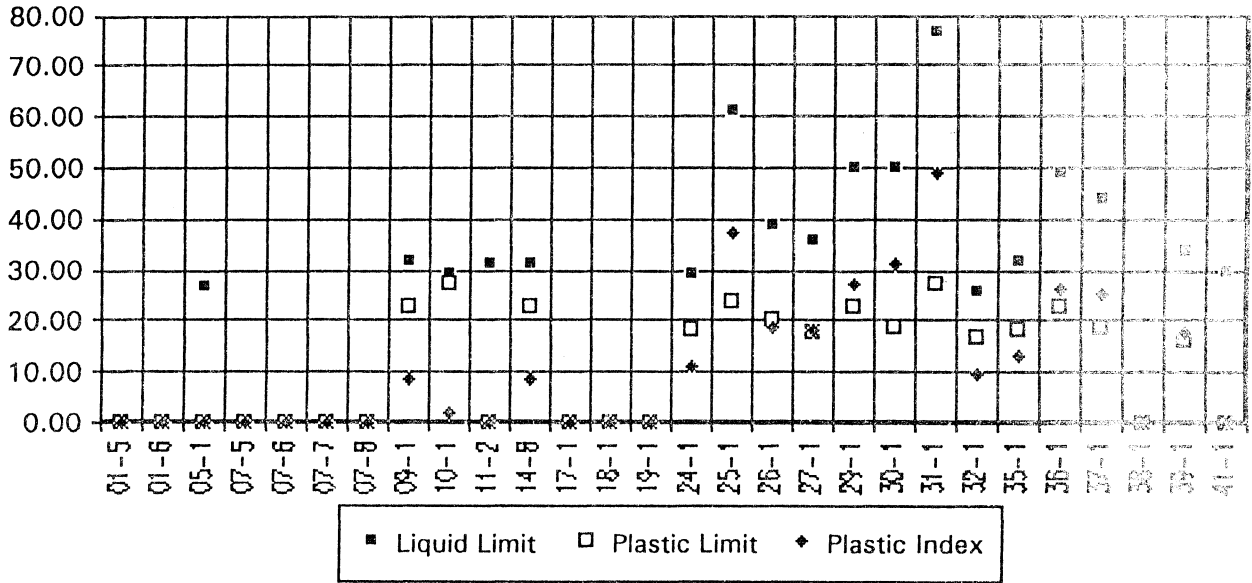
Among the laboratory tests the Arkansas Highway and Transportation Department normally uses to determine the stability of a roadbase are the Atterberg limits (Dave Lumbert, personal communication). Recognizing that the amount of water in a fine-grained soil has dramatic effects on its properties, we performed Atterberg limit tests on selected samples of loesses from various failed and unfailed sites. In order to assure that our test results would produce the same types and kind of numbers that the highway department would get themselves, we used their laboratory, tools, methods (AHTD Test Method 353 & 354), and report forms. Liquid limit, plastic limit, and plastic index were determined for samples of displaced material from 15 sites and samples of undisturbed material from 23 sites. Ignoring those samples that were indeterminate for the values tested, we found no significant differences between the failed and unfailed silts (figure 2). Samples of the collapsed material did appear to have a more limited range of test values than the unfailed materials, however.

Figure 2. Atterberg limits for loess samples collected from Crowley's Ridge. The first numbers of the labels across the base of the graph are the site numbers. A) Samples of failed material. B) Samples from unfailed sites. Some samples of unfailed material were collected adjacent to landslides.

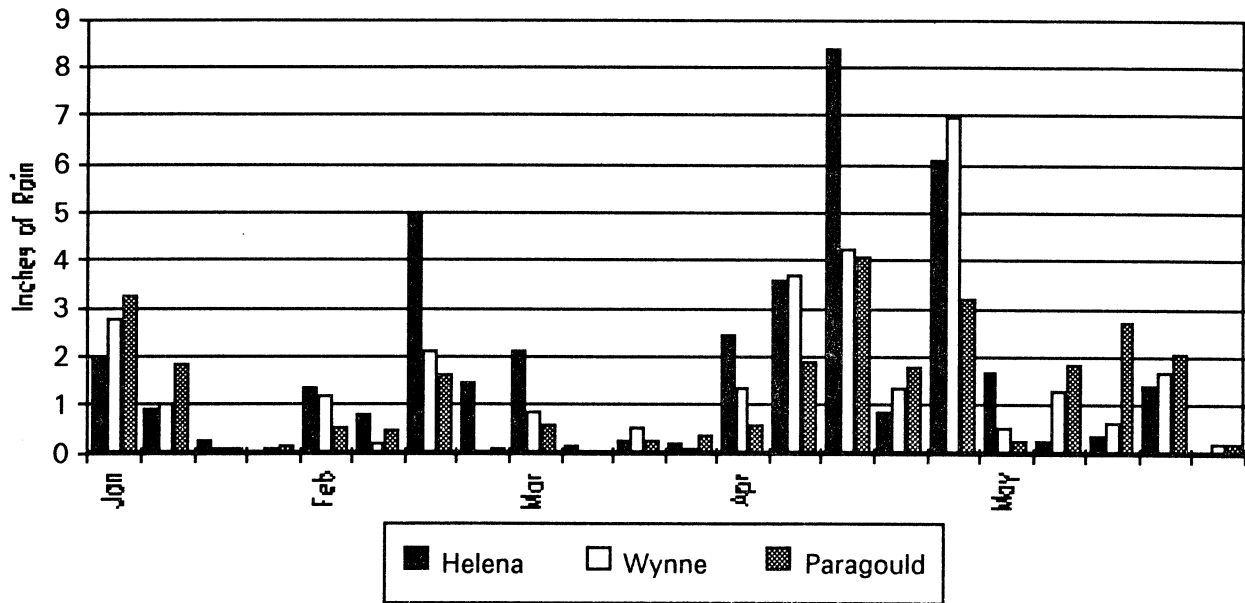
Figure 3. Weekly precipitation for Helena, Wynne, and Paragould for the first five months of 1991 (NOAA, 1991). Most of the landslides that developed this year occurred during or shortly after the period of increased rainfall in April.

Aseismic, non man-induced landslides are the result of several interrelated factors. Degree of slope, nature of the soils, vegetation cover, but most especially excessive water play a role in their development (Nilsen and Turner, 1975; Killey and others, 1985; Keefer et al, 1987, Baskerville, 1991). Almost all of the displacements we observed occurred on slopes steeper than 20 degrees. Most of the landslides occurred in fine-grained materials, usually loess, although some sand and gravel were the major displaced components in a few cases. Landslides on undisturbed wooded hillsides were rare; most displacements were found associated with slopes that recently had been naturally or culturally modified. Few fresh landslides were observed on Crowley’s Ridge until the rainy period that began in early April (figure 3) suggesting that water is the proximal causative agent of landslides under normal conditions.

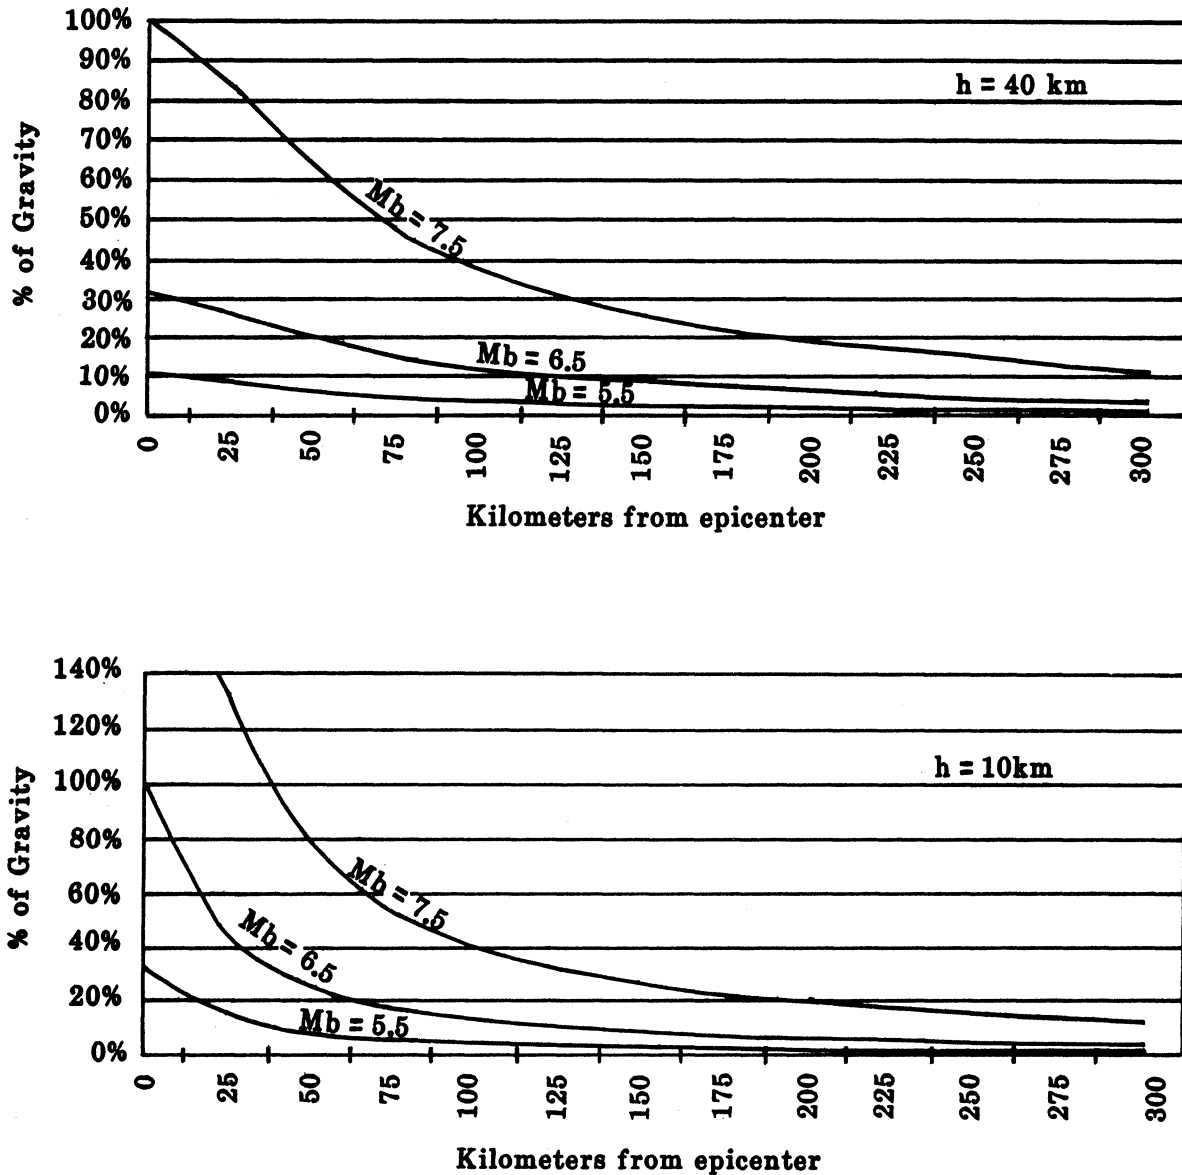
Figure 7. Peak horizontal ground acceleration to be expected at various distances from the epicenter of large New Madrid earthquakes. Graph based on the equation:  $\log ah = 0.57 + 0.50 \cdot M_b - 0.83 \cdot \log((R^2 + h^2)^{.5}) - 0.00069 \cdot R$  published by Nuttli and Herrmann (1984) where  $ah$ =peak horizontal ground acceleration (cm/sec),  $M_b$ =body wave magnitude,  $R$ =epicentral distance (km), and  $h$ =depth (km).

Keefer (1984) recommends  $M_L = 4.0$  as the smallest earthquake capable of causing a landslide. Applying this value to the equation for peak horizontal ground acceleration suggested by Nuttli and Herrmann (1984) indicates that a minimum acceleration of about 5% of gravity is needed for slope failure. Plotting the peak horizontal ground acceleration for a range of large seismic events and depths against distance implies that most large seismic events will produce sufficient forces to induce landsliding along significant portions, if not all, of Crowley's Ridge (Figure 7).
