MISCELLANEOUS PUBLICATION 24

**A Model for Predicting Bedrock Failure in the Arkansas
River Valley Region of Western Arkansas**

Cathy Baker, Ph.D.
Professor of Geology
Arkansas Tech University
Russellville, Arkansas

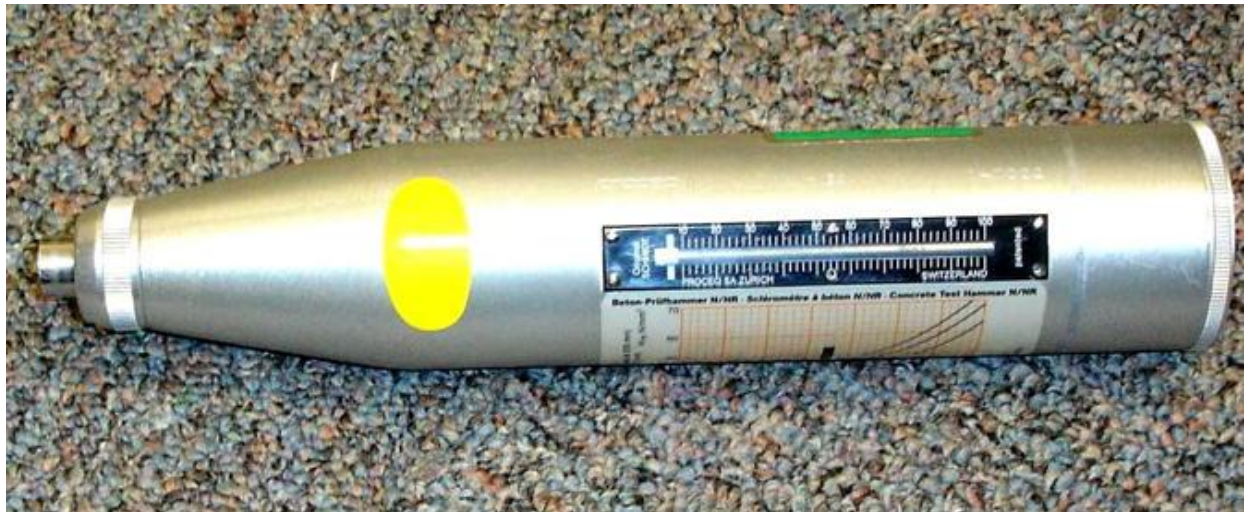
Figure 2a. *N-Style Schmidt Concrete Testing Hammer.*

Hardness as a component of rock strength is measured in the modified Selby method using a *Schmidt N-Style Concrete Testing Hammer*. The Schmidt brand hammer measures the rebound of a spring loaded mass impacting against the surface of a rock exposure. The test hammer strikes the rock face at a defined energy. The rebound is dependent on the hardness of the rock face. The Schmidt hammer scale is an arbitrary scale ranging from 10 to 100 (Figure 2a). *N-Style Schmidt Concrete Testing Hammer*). By reference to the conversion chart, provided by the Schmidt Company, the rebound value can be used to determine the compressive strength. In the Selby method, the arbitrary scale numbers are sufficient for a hardness determination. Determination of specific compressive strength is not necessary. For example, if the arbitrary reading derived from the *Schmidt Hammer* is "50", the corresponding "r" value of the modified Selby model is "18" (see Table 2.). When conducting the test, the hammer should be held at right angles to the rock faces which in turn should be flat, smooth, and lacking fracture (Figure 2b.).

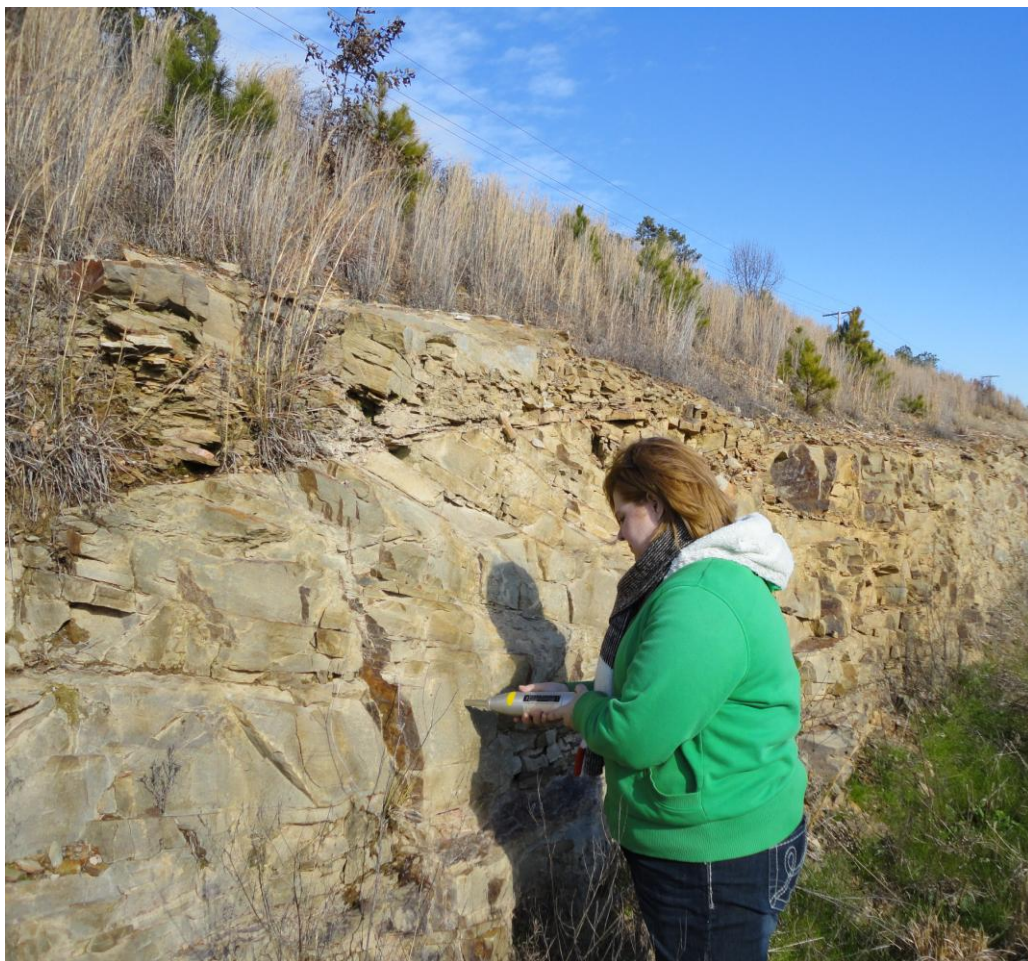
Figure 2b. *Demonstration of use of N-Style Schmidt Concrete Testing Hammer.*

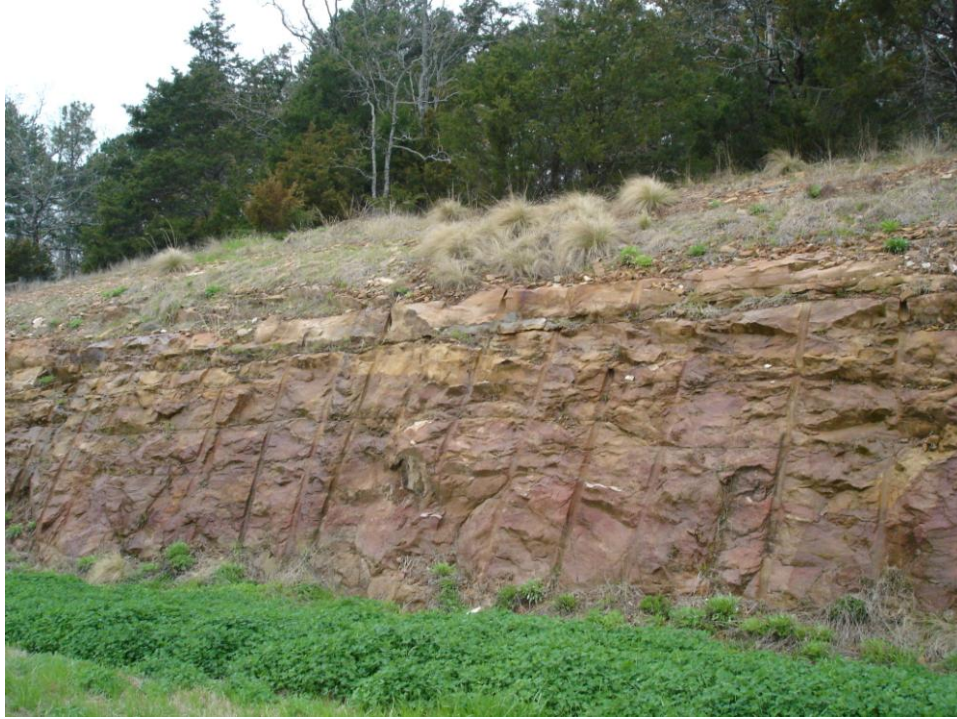
Figure 3a. Unweathered sandstone: Hartshorne Sandstone at the I-40 Interchange #78 west of Russellville.

Selby's original strength classification defined degrees of weathering with respect to crystalline rocks (Selby, 1993, Table 6.3, page 96). For this study, it was necessary to define levels of weathering with respect to sedimentary rocks. The nature of the levels of weathering and corresponding "r" values for sedimentary rocks are defined in tables 3 and 4 and illustrated in figures 3a-f and 4a-f. Levels of weathering are obtained by visual inspection. Aspects of weathering compiled include:

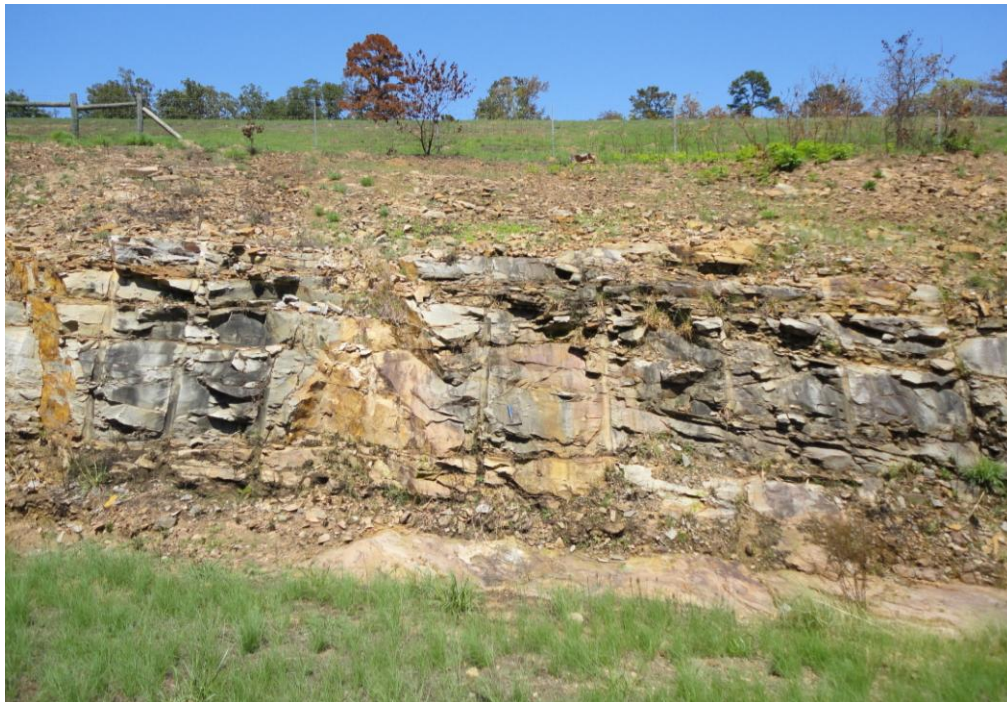
Figure 3b. Slightly weathered sandstone: Hartshorne Sandstone at the I-40 Interchange #78 west of Russellville.

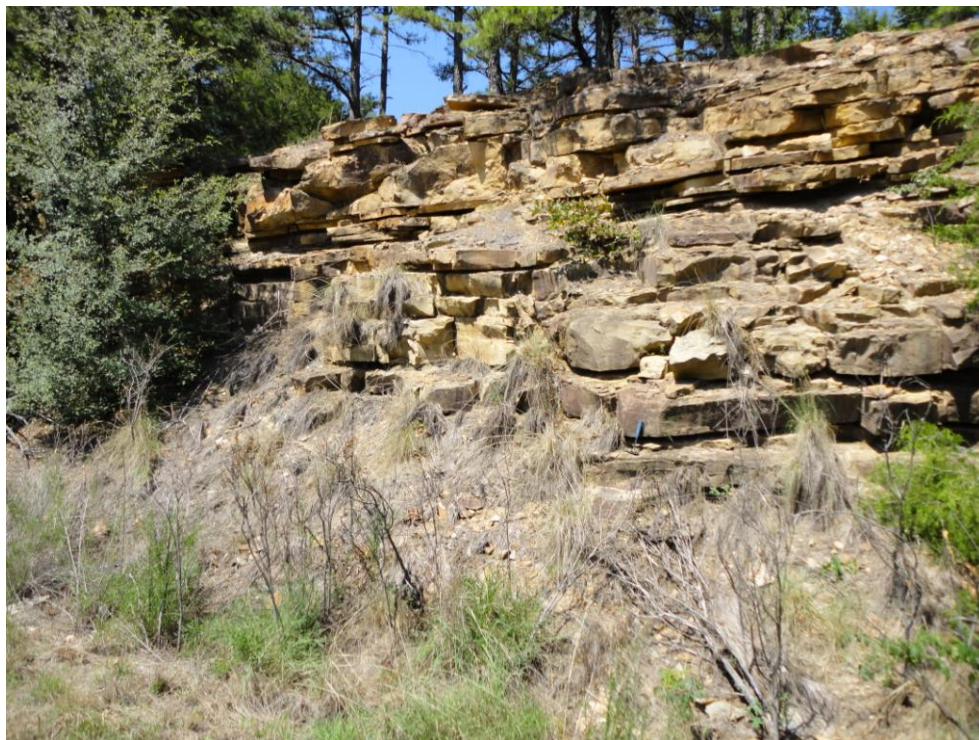
Figure 3c. Moderately weathered sandstone: Hartshorne Sandstone on I-40 approximately one-half mile east of Interchange #74 at London.

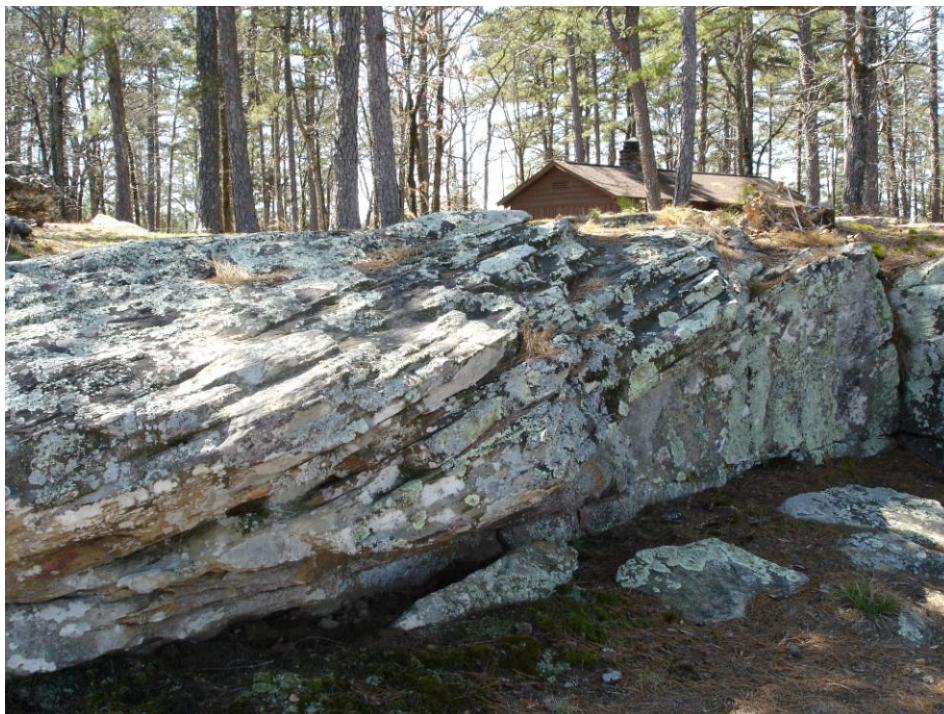
Figure 3d. Moderately weathered sandstone: Hartshorne Sandstone near Mather Lodge at Petit Jean State Park located approximately 14 miles east of Centerville on AR Hwy. 154.

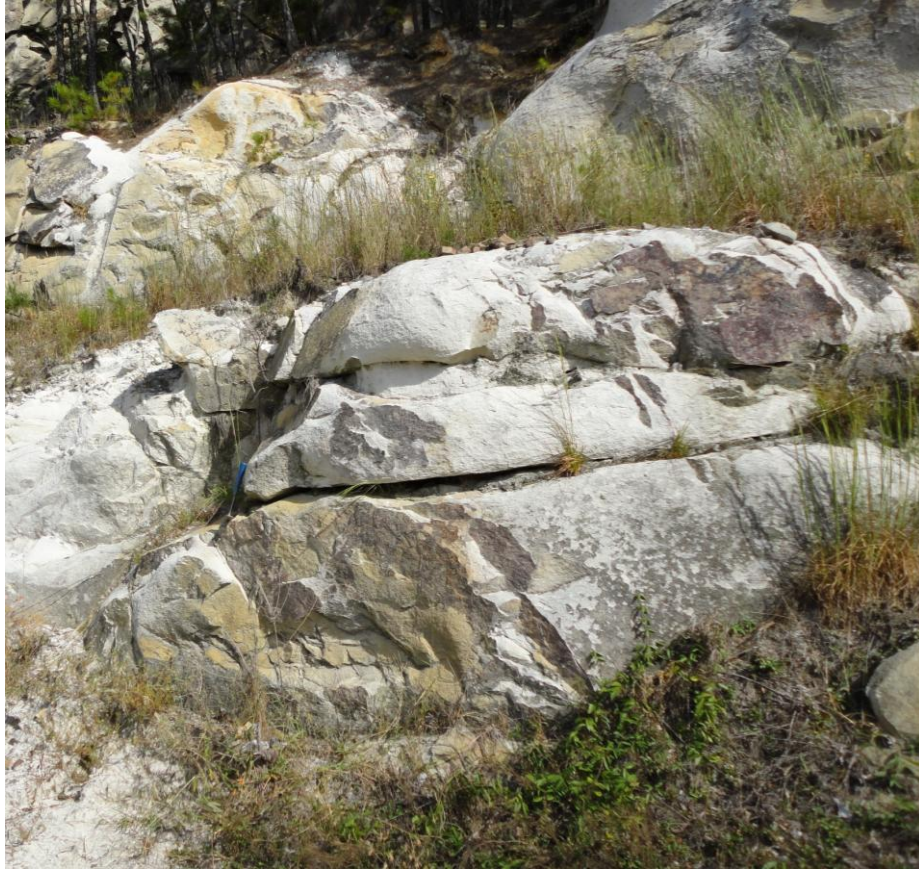
Figure 3e. Heavily weathered sandstone: Hartshorne Sandstone at Cove Mountain and AR Hwy. 247 approximately 3.6 miles south of Pontoon.

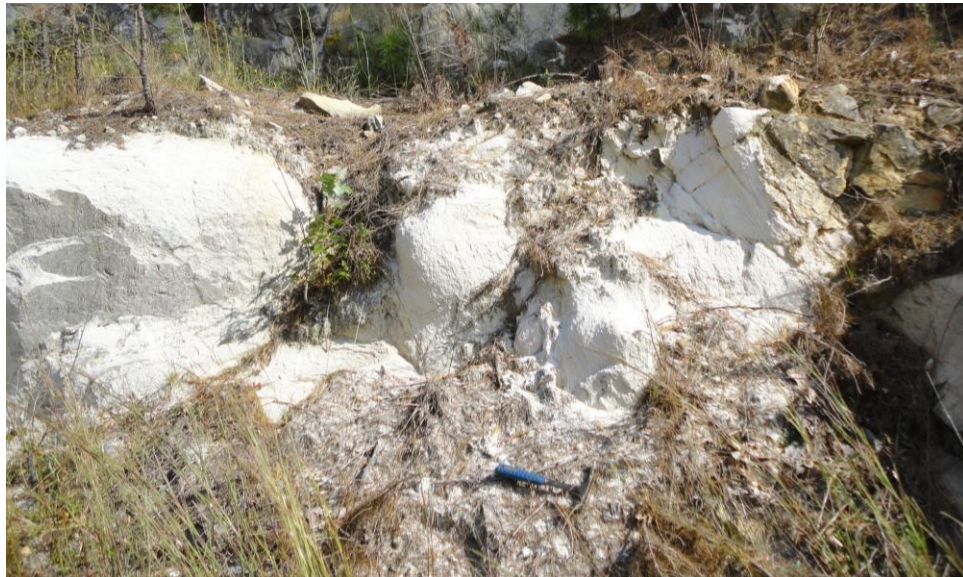
Figure 3f. Almost completely weathered sandstone: Hartshorne Sandstone at Cove Mountain and AR Hwy. 247 approximately 3.6 miles south of Pontoon.

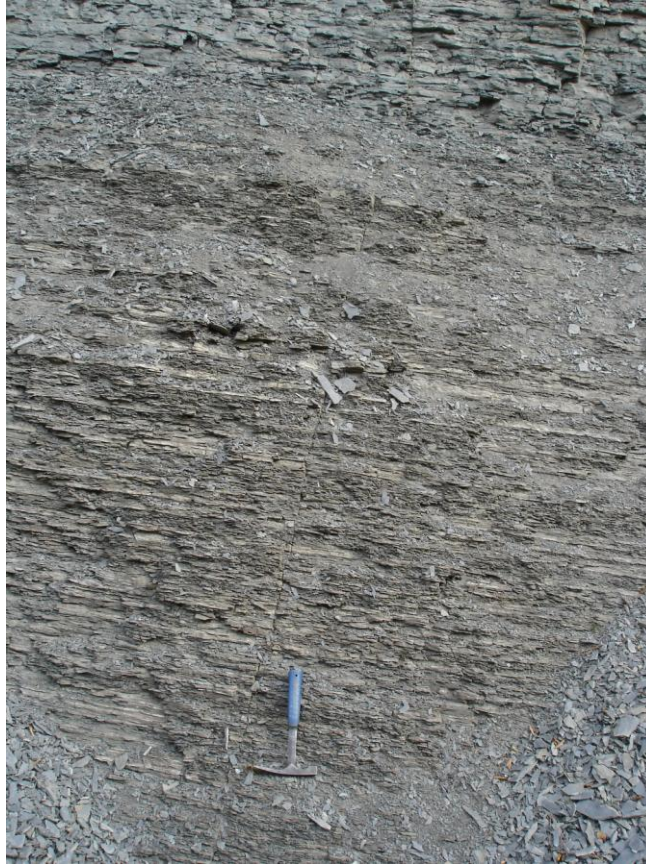
Figure 4a. Unweathered to slightly weathered shale: Atoka Formation along AR Hwy. 9 roughly 1.75 miles south of I40 Interchange #108 at Morrilton.

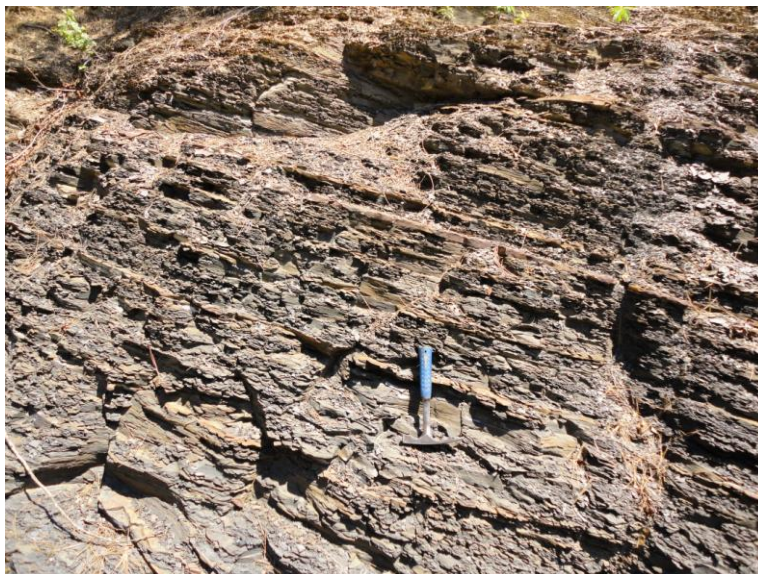
Figure 4b. Moderately weathered shale: McAlester Formation at the spillway of Horsehead Lake approximately 2.7 miles north of Hunt on AR Hwy. 164.

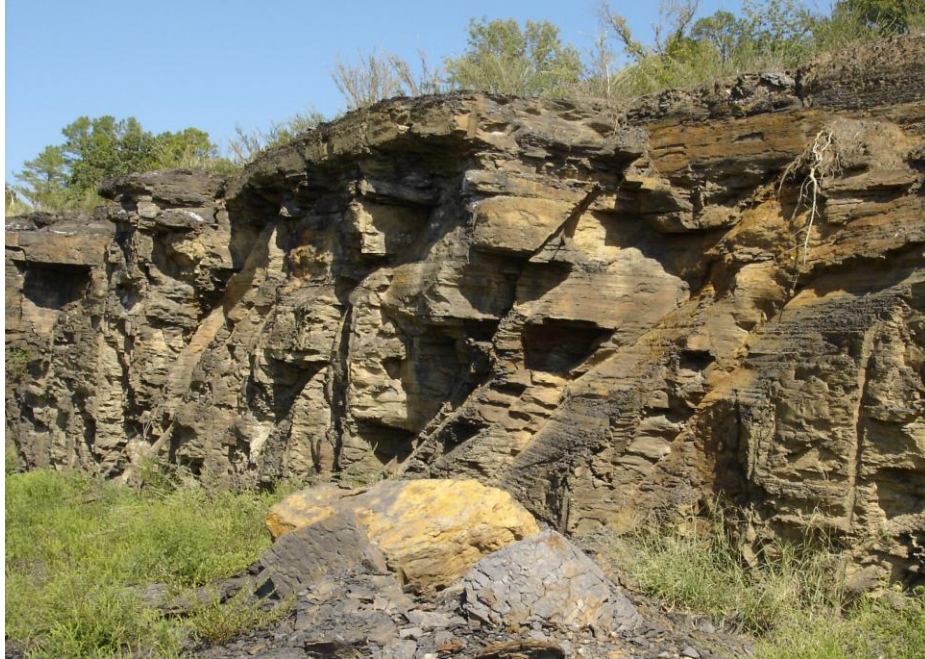
Figure 4c. Moderately weathered shale: Atoka Formation along AR Hwy.7 nearly two miles north of the I-40 Interchange #81 at Russellville.

To illustrate the assessment of an exposure with respect to weathering, a photograph of an exposure of a shale can be used (Figure 4c.). The outcrop consists of very thinly-bedded layers of silty shale. Weathering has resulted in some disintegration along the bedding planes, producing numerous platy fragments and some clay residue on the exposure surface. The base of the outcrop has a small talus pile of shale fragments containing minor amounts of clay. Staining by iron oxide and hydroxides is clearly visible. Limonitic stains predominate. Shale layers still in place are very dark gray to black in color. Weathered platy fragments are somewhat “bleached” to a lighter gray color. Weathered persistent joints with thin infill are common. Based on the collective nature of weathering, the level of weathering would be considered “moderately weathered” and receive an “r” rating of “5”.

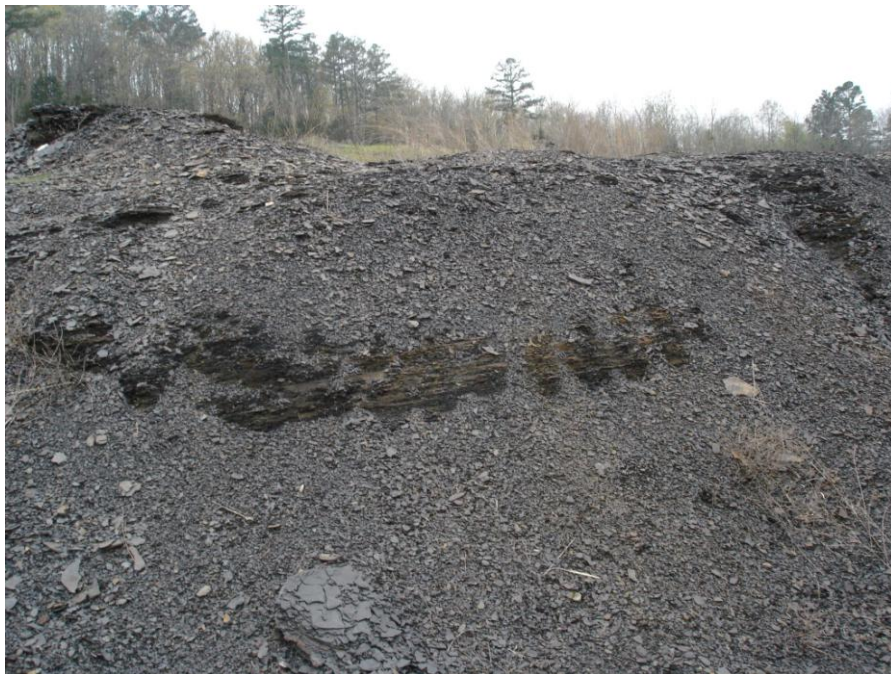
Figure 4d. Heavily weathered shale: McAlester Formation at Robertsons Lane off US Hwy. 64 nearly two miles west of I-40 Interchange #78 west of Russellville.

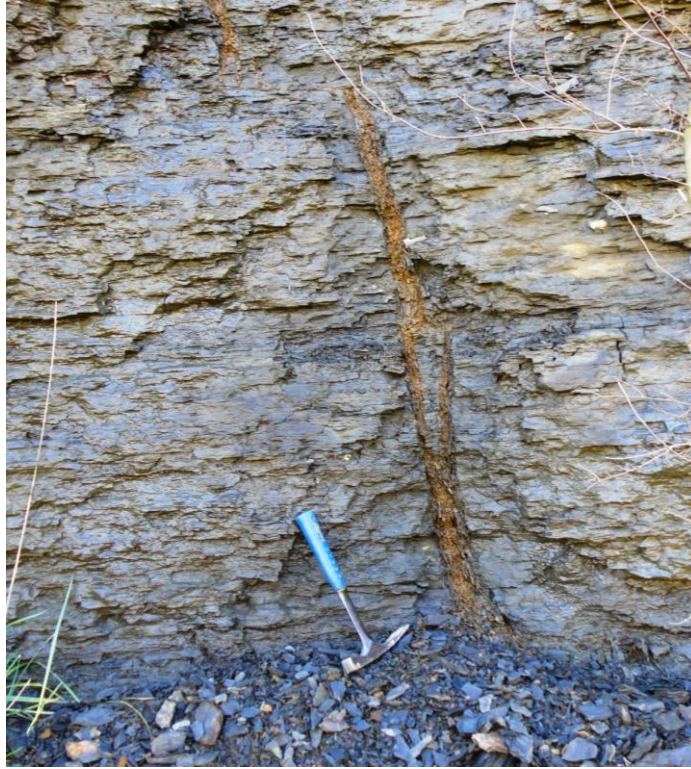
Figure 4e. Heavily weathered joint plane in shale: Atoka Formation along AR Hwy. 22 nearly two miles west of Dardanelle, Arkansas. The photograph illustrates development of platy shale fragments aligned along the joint plane.

Joint planes with shale fragment infill and clay infill are especially obvious features that signify higher levels of weathering. In the Arkansas River Valley Region, infilled joints are almost exclusively developed in shales, both in the Atoka and McAlester formations. Tectonic joints tend to be persistent throughout silty shale facies of the Atoka Formation and the McAlester Formation. Mechanical hydration or dehydration and chemical hydrolysis have produced small platy fragments of silty shale and clay along tectonic fractures. Continued hydration, dehydration and hydrolysis accompanying groundwater seepage along tectonic fractures recrystallize the grains into a parallel alignment with the joint surfaces (see Figure 4e.). Moderately weathered silty shales may contain joint infill of up to 20 mm in width; whereas more highly weathered silty shales may possess joint infill zones that reach one-third of a meter in width.

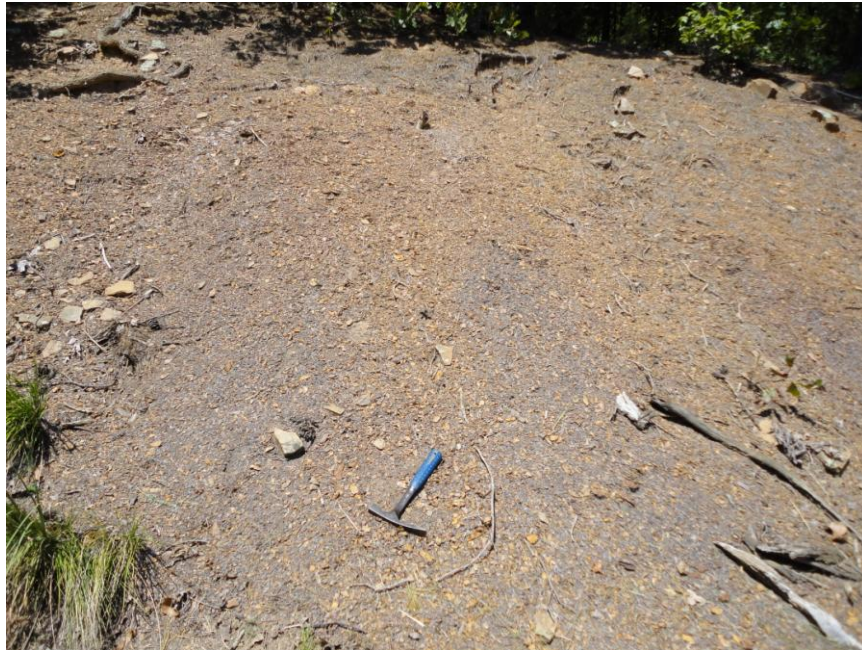
Figure 4f. Nearly completely weathered shale: McAlester Formation at Round Mountain on Milky Way Lane near Arkansas Nuclear One west of Russellville.

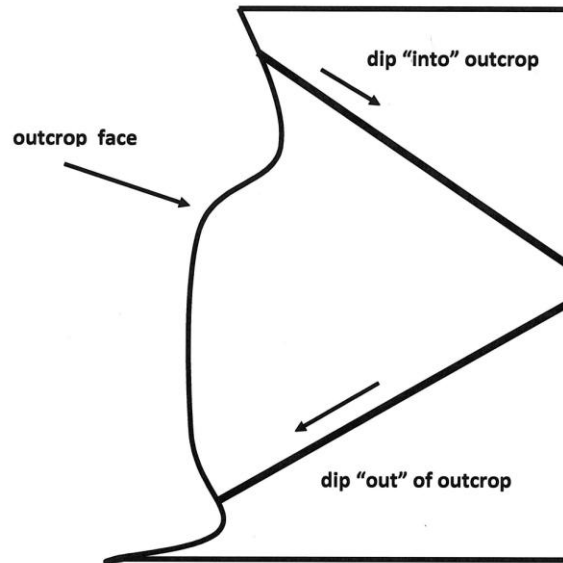
Figure 5. Illustration of joint and dip orientation terminology.

Bedrock of the Arkansas River Valley Region is almost exclusively sedimentary and, therefore, layered. The attitude of the strata of the area, like joint orientation, can be quite variable: vertical, horizontal, or tilted. Research for this study has shown that failure along bedding planes and failure along joint planes occurs under the same conditions. For example, this study shows that sandstones begin to slide at approximately 26° of dip whether the plane is a bedding plane or a persistent joint plane. Dip of bedding and orientation of persistent joints therefore, are treated as synonymous in the adapted Selby method. In addition to being vertical, horizontal or inclined, planes may parallel the outcrop slope face, or may intersect the outcrop at an angle. Planes may dip “into” the outcrop slope face or dip “out” of the outcrop (Figure 5).

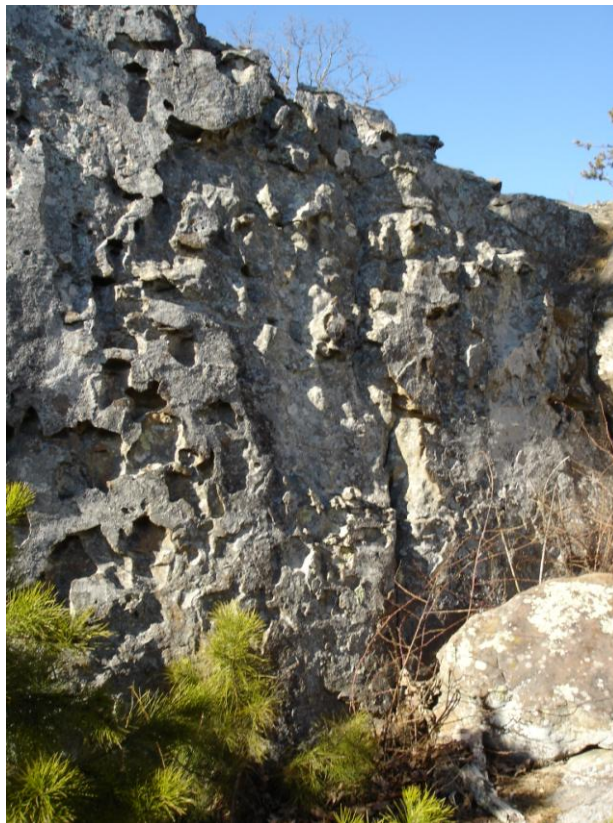
Figure 6a. Silica case hardening: Hartshorne Sandstone at Mount Nebo State Park in Yell County, roughly seven miles west of Dardanelle, Arkansas.

Silica is common in all rocks studied in the study area. Silica is common in the sands of the Hartshorne Sandstone and in the sands, silts, and clays of the Atoka Formation. Mobilization of silica during weathering produces fluids high in silica that often precipitate along bedding planes and joints. Precipitated silica can produce hard “veneers” known as “case hardening” (Figure 6a). The combination of silica and iron oxides accumulated along bedding planes and joint surfaces results in differential weathering and erosion that creates a distinctive rusty-colored “waffle-iron” pattern upon weathering known as “liesegang banding” (Figure 6b). Silica and iron oxide concentrations can produce zones of higher cementation and greater hardness. Surfaces with pervasive case hardening and/or liesegang banding are highly weathered surfaces; however, the rock surfaces are likely to be hard and yield higher “r” values for hardness than rocks with low amounts of silica and iron oxides.

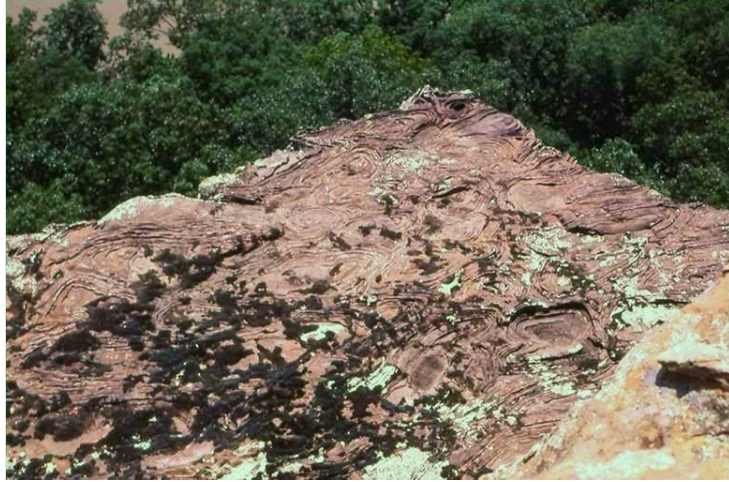
Figure 6b. Liesegang: Hartshorne Sandstone along Rim Rock Road roughly one-half mile upstream from Dardanelle Lock and Dam at Dardanelle.

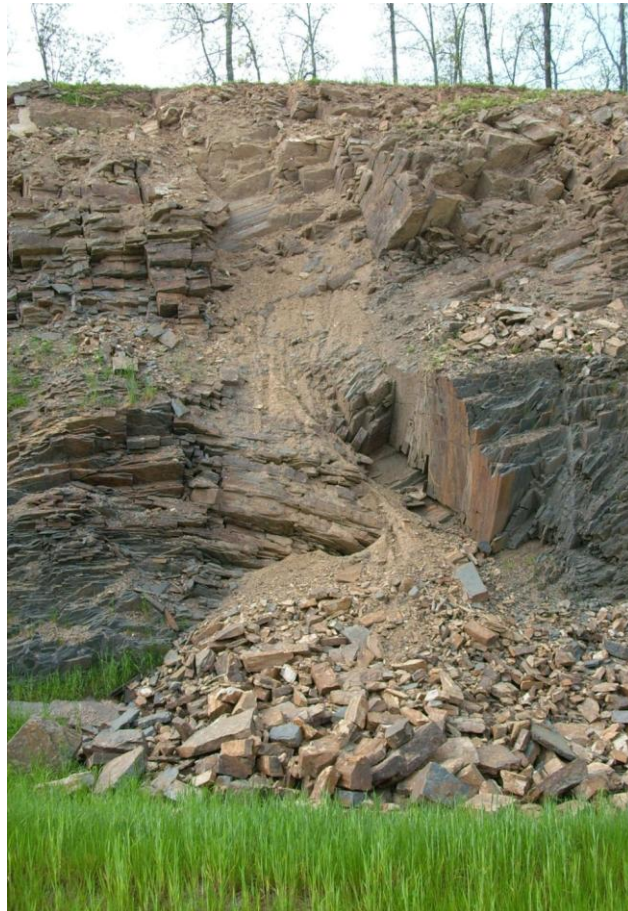
Figure 7. Failure along persistent structural fracture planes: Atoka Formation (sandstone facies) at Interchange #124 on I-40 approximately two miles west of Conway. Strata dip “into” the outcrop. Joint planes dip “out” of the outcrop.

The total “r” value of 48 ranks the exposure as “weak” and likely to fail. Examination of the photograph of the outcrop (Figure 7) reflects catastrophic failure.

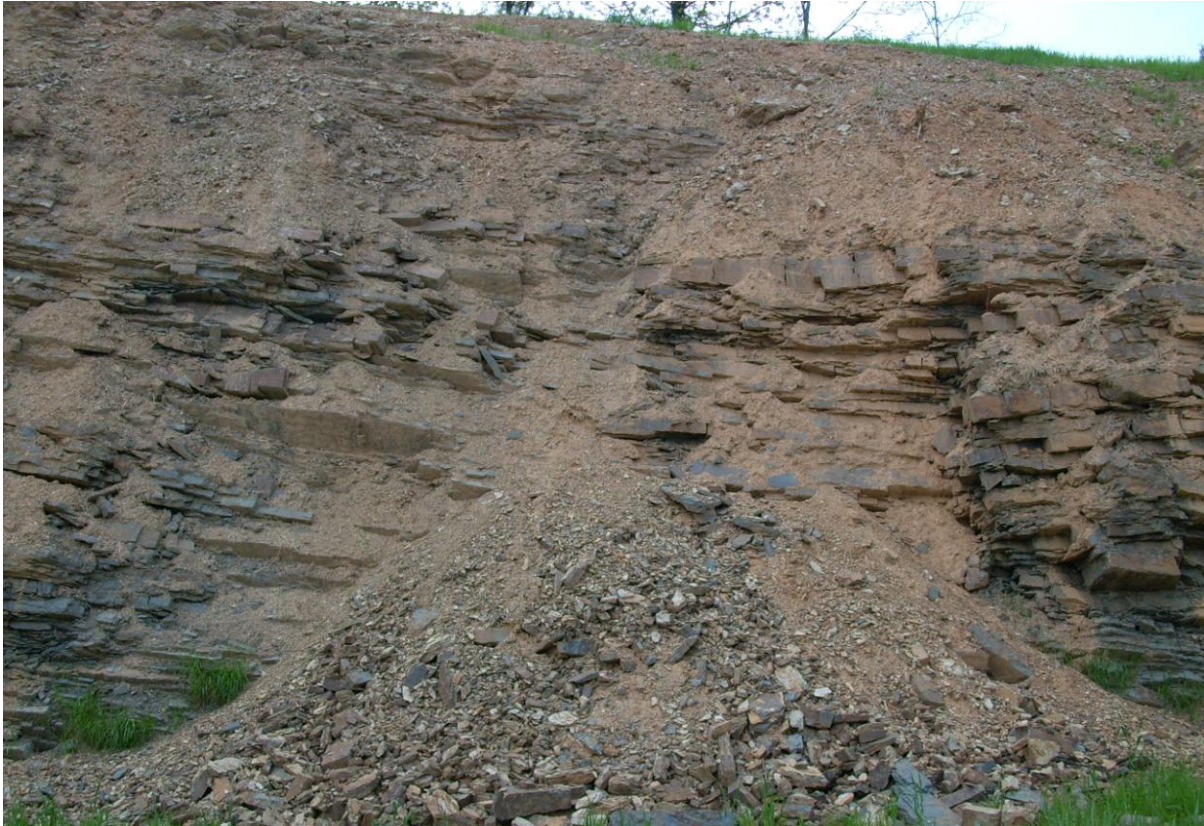
Figure 8. Assessment Example: Atoka Formation (sandstone facies) at Interchange #124 on I-40 approximately two miles west of Conway.

Figure 8 illustrates a typical outcrop that was assessed using the Modified Selby Model for Bedrock Failure Prediction (Table 2). The outcrop consists of a slightly sloping bedrock exposure created during the construction of an interchange of I-40 west of Conway, Arkansas (Appendix: site 167). Atoka Formation sandstones with minor shale partings comprise the road cut. All criteria used in the evaluation are listed as follows:
